APPENDIX J - SUPPORT FACILITIES

MINOT FIRE STATION NO. 3 - OPTION 1

RE: Fire Station #3 – Minot Airport
2510 N. Broadway-Minot, ND 58703

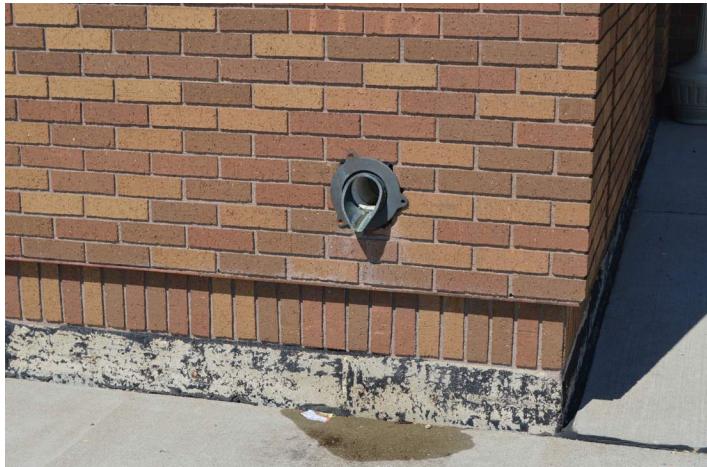
The existing west roof downspout was removed and relocated to the east Living room Addition, because of the high water table on the west and the constant freezing of the west downspout.

New Roof Downspout - East Elevation

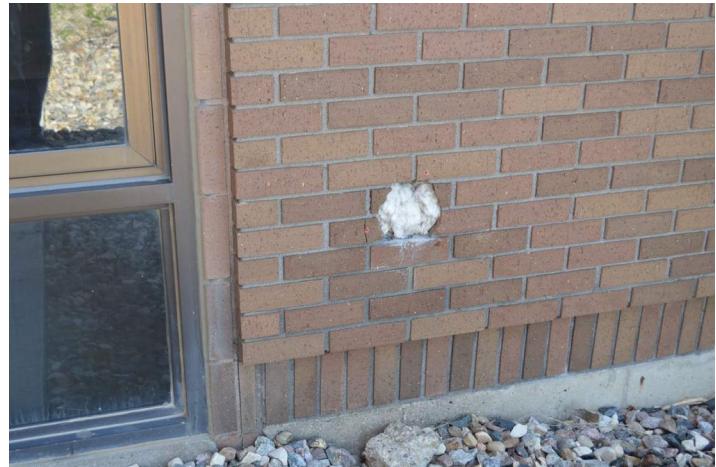
Existing Downspout Location - West Entrance Elevation

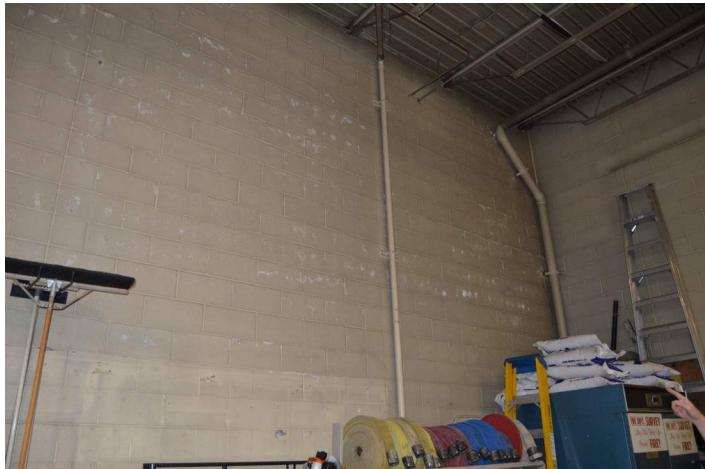
The 1978 Addition exterior walls are constructed of face brick, 8" cmu block, with no insulation. The exterior brick finish is in good condition. The north interior cmu block wall of the north Apparatus bay showing signs of efflorescence at the open cells of the cmu blocks. The paint on the north wall was breaking away at the areas of efflorescence.

Apparatus Bay #1: Painted CMU; Efflorescence on north wall & some spalling of CMU block, dirt/dust on CMU walls; Fair Condition.

Apparatus Bay #1 - Efflorescence on North Wall

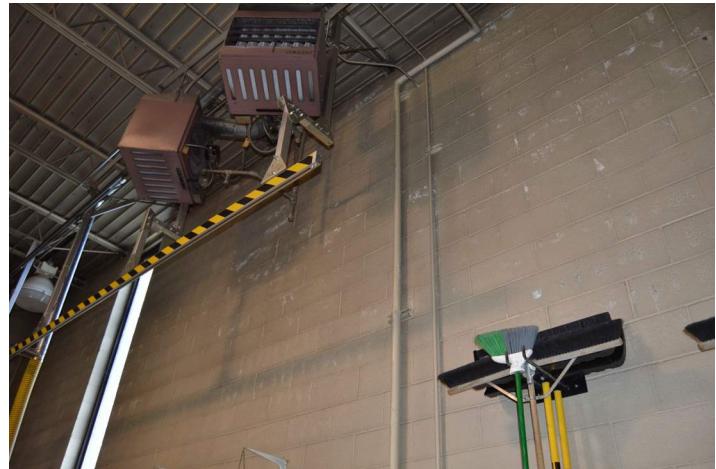
Apparatus Bay #1 - Efflorescence on North Wall

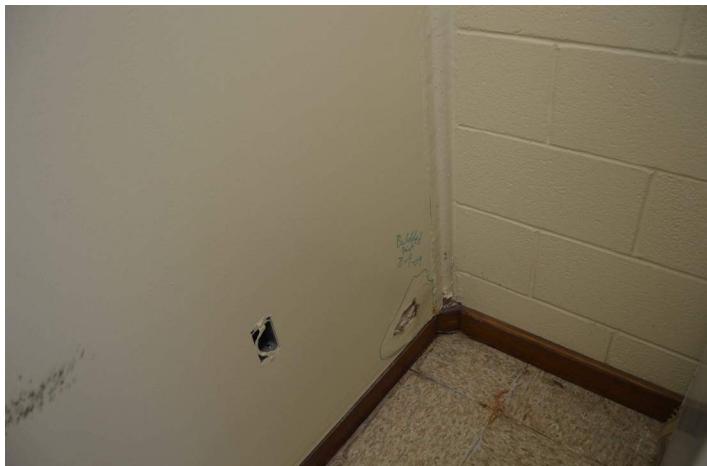
Kitchen: Painted CMU, painted gypsum board & tile backsplash; Water damage in gypsum board wall in NW corner, adjacent to shower; Good Condition.

Kitchen - Water Leak on West Wall

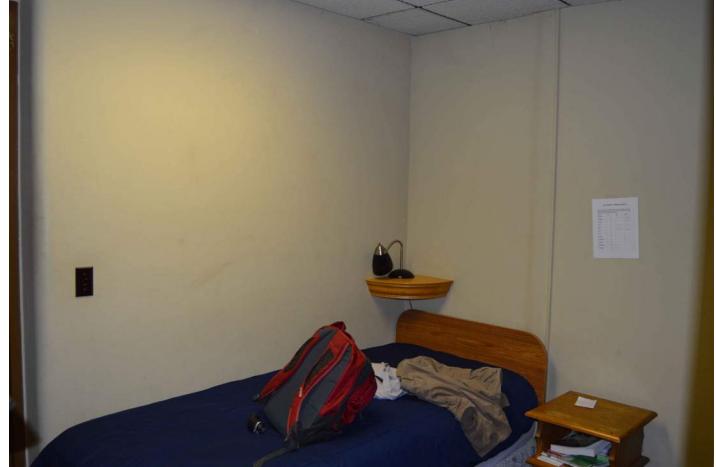
Dormitory window unit has two fixed panes & one operable pane. This window unit is covered with gypsum board sheathing, because of the cold air drafts: Poor Condition.

Dormitory - Looking Southwest at Window Infill

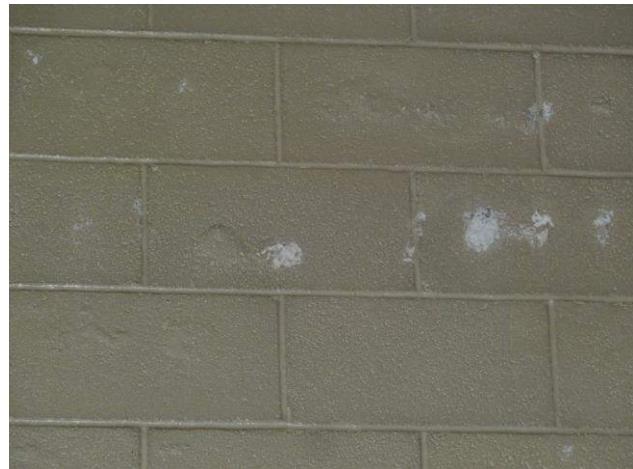
Photo #9: close up of spalling and white Efflorescence at north wall of 1978 addition.

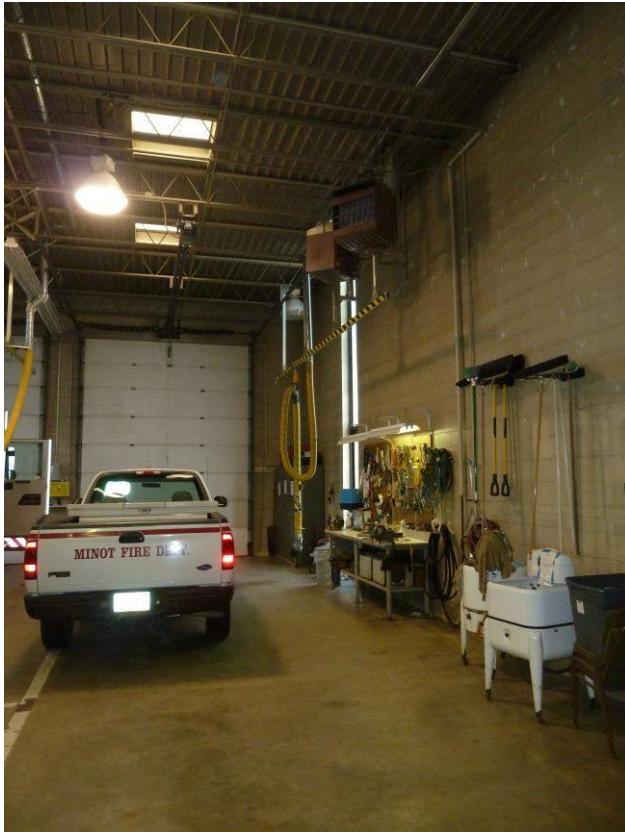
Photo #8: Viewing NW corner of 1978 addition. Note the white efflorescence and spalling on north wall.

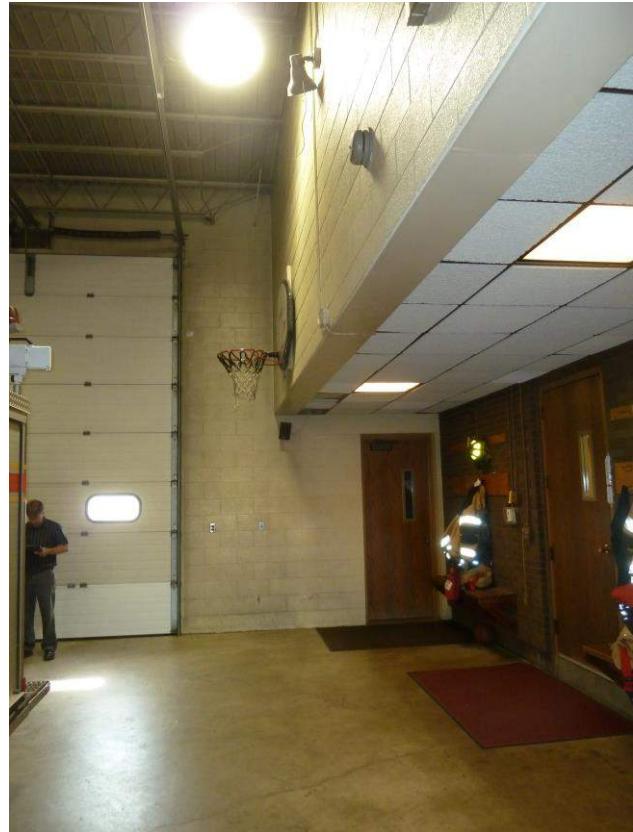
Photo #10: SE corner of 1978 addition.

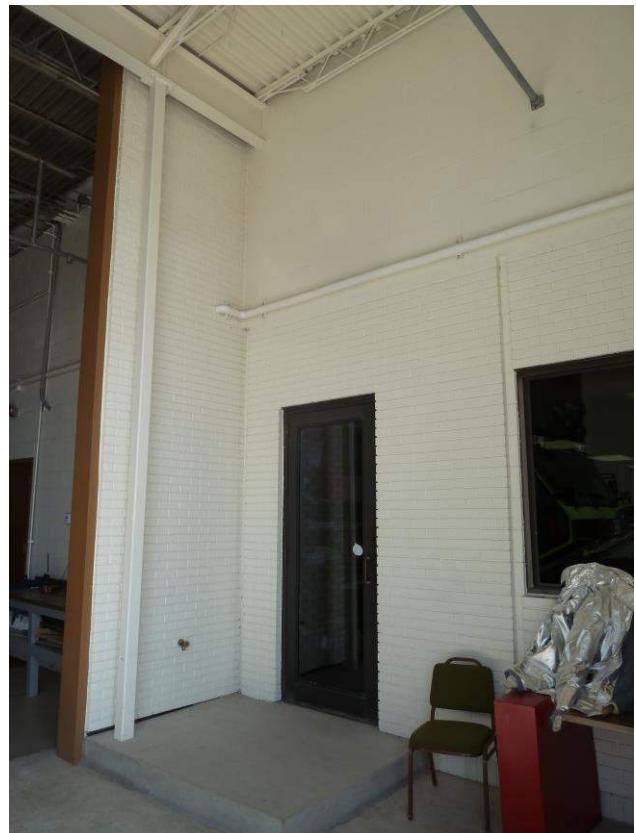
Photo #15: Wall between living quarters addition and 2011 addition extended apparatus bay.

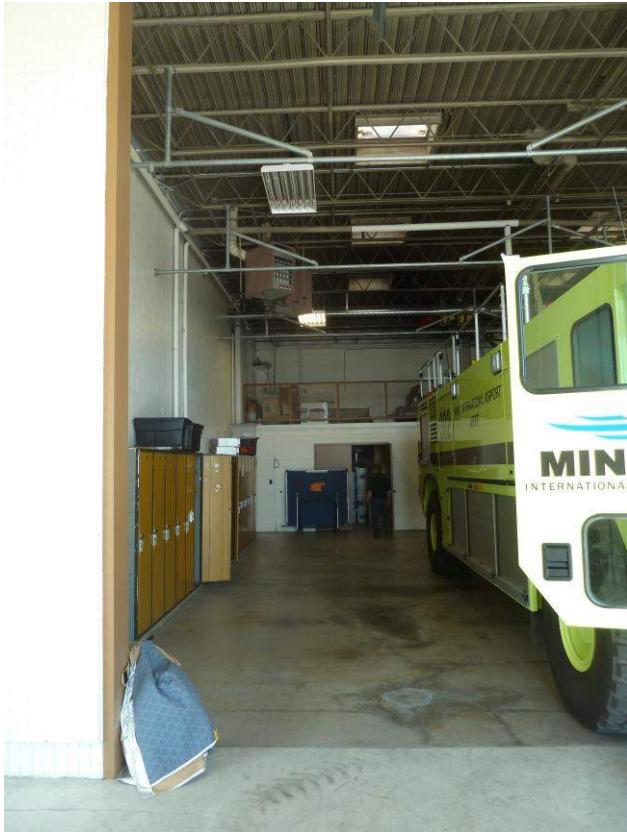
Photo #16: South end of original building apparatus bay and mezzanine beyond (looking west).

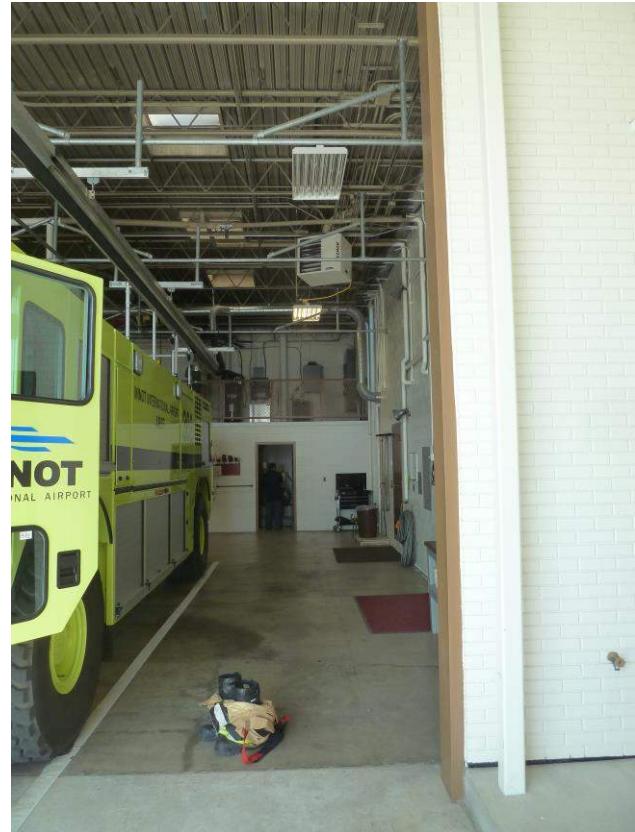
Photo #18: North end of original building apparatus bay and mezzanine beyond (looking west).

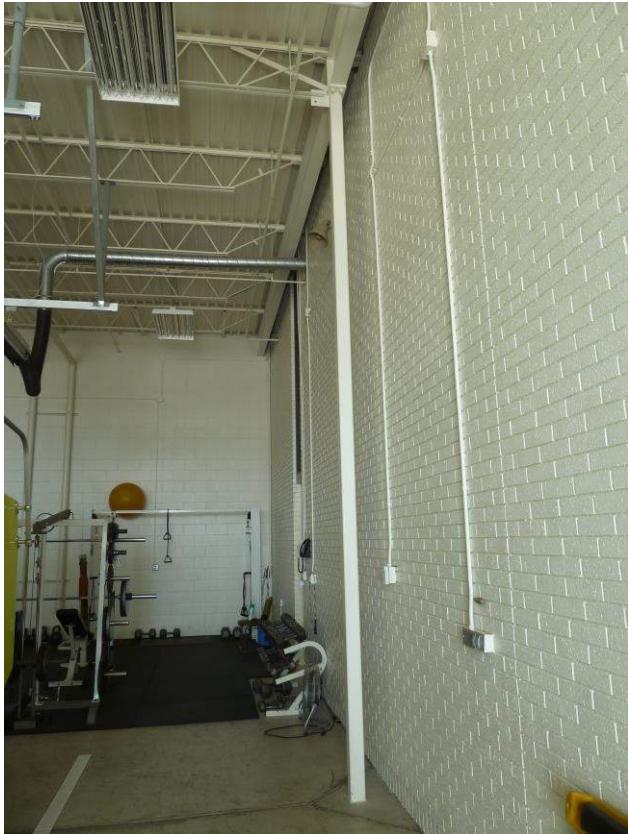
Photo #20: South wall of original building apparatus bay, viewing the column and beam line for the 2011 addition.

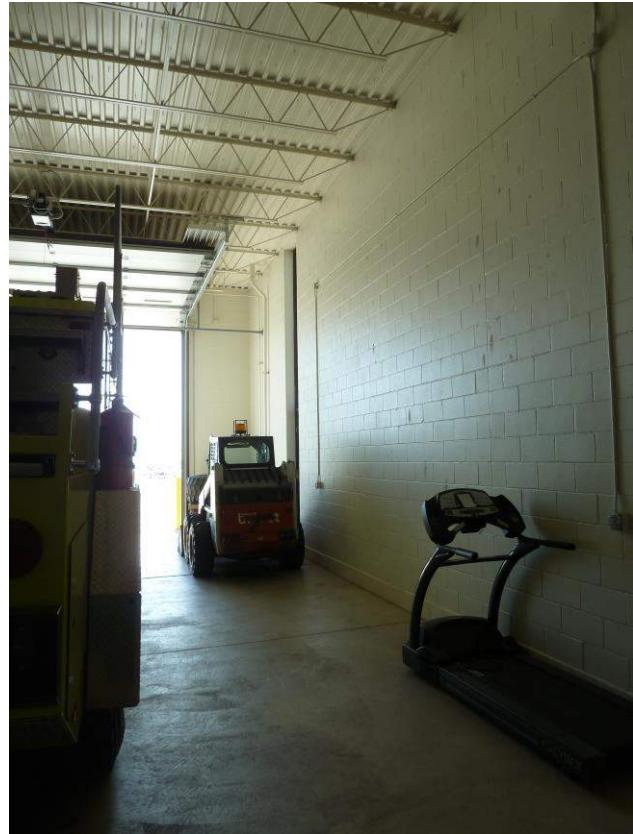
Photo #21: South wall of 2011 addition (looking East)
