APPENDIX R - ALTERNATIVES

Because there were a substantial number of alternatives prepared for the Minot International Airport Master Plan process, this appendix provides a copy of those alternatives by area and time sequence. The analysis and decisions related to alternatives are provided in **Chapter 5: Alternatives Analysis**.

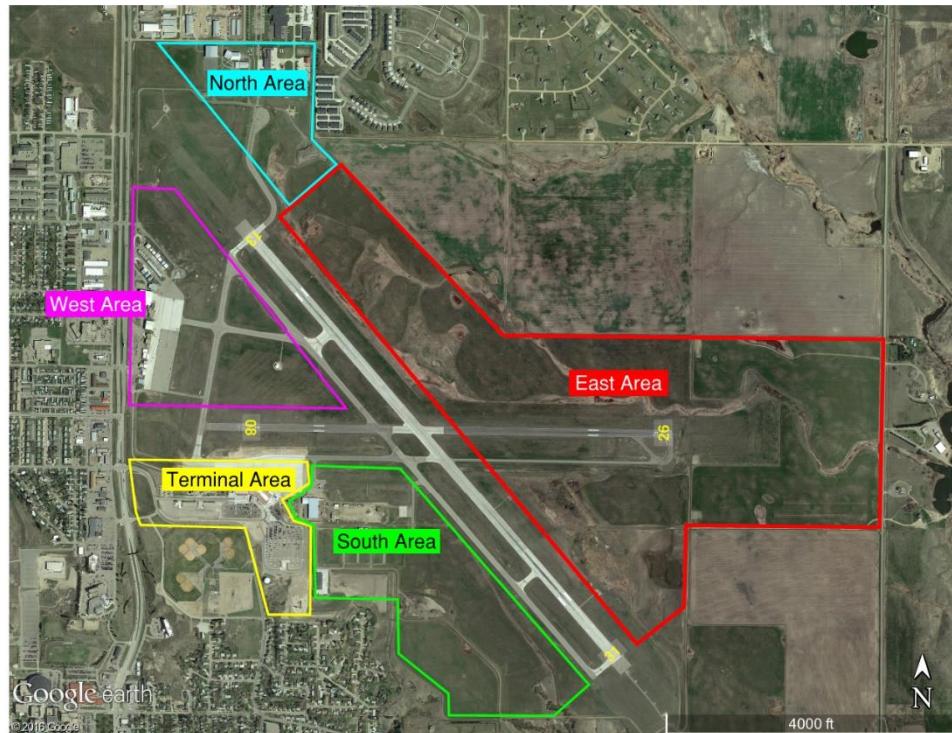
For analysis purposes, the areas of the airport were divided into regions based on geography and similar uses. The diagram below is a general layout of these prescribed areas.

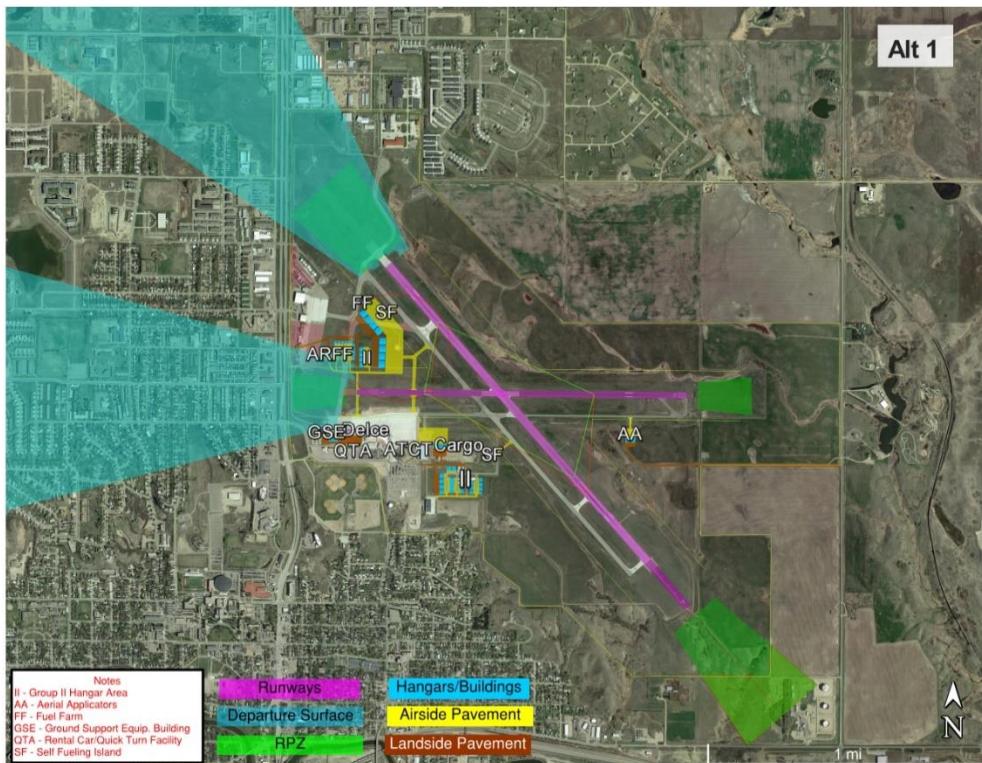
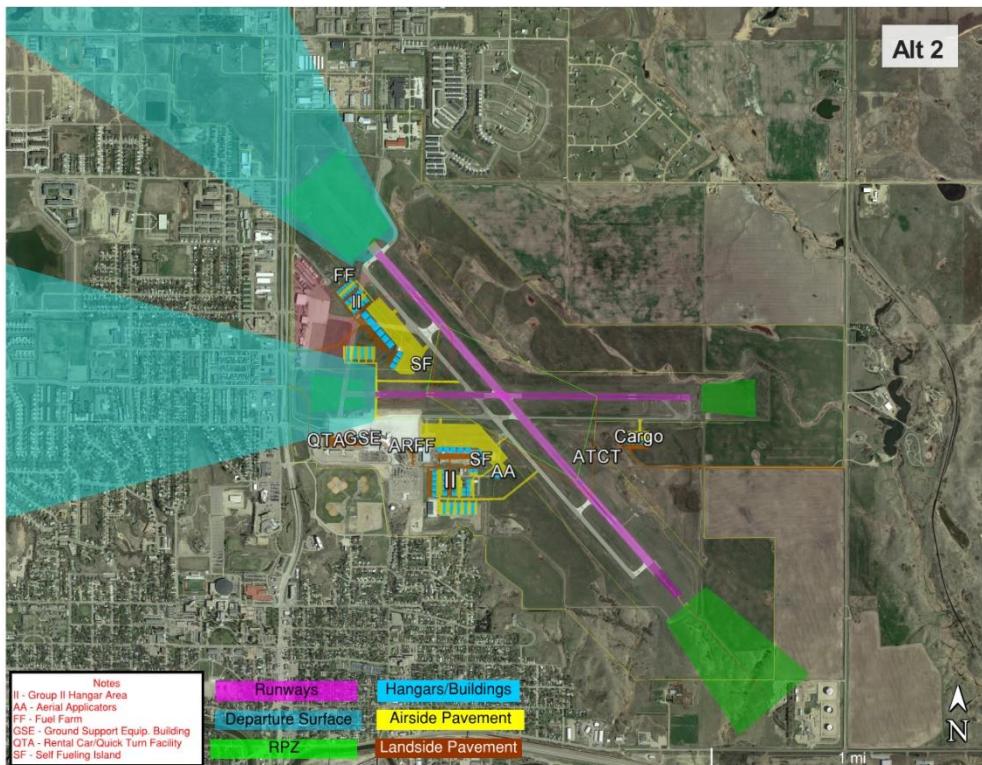
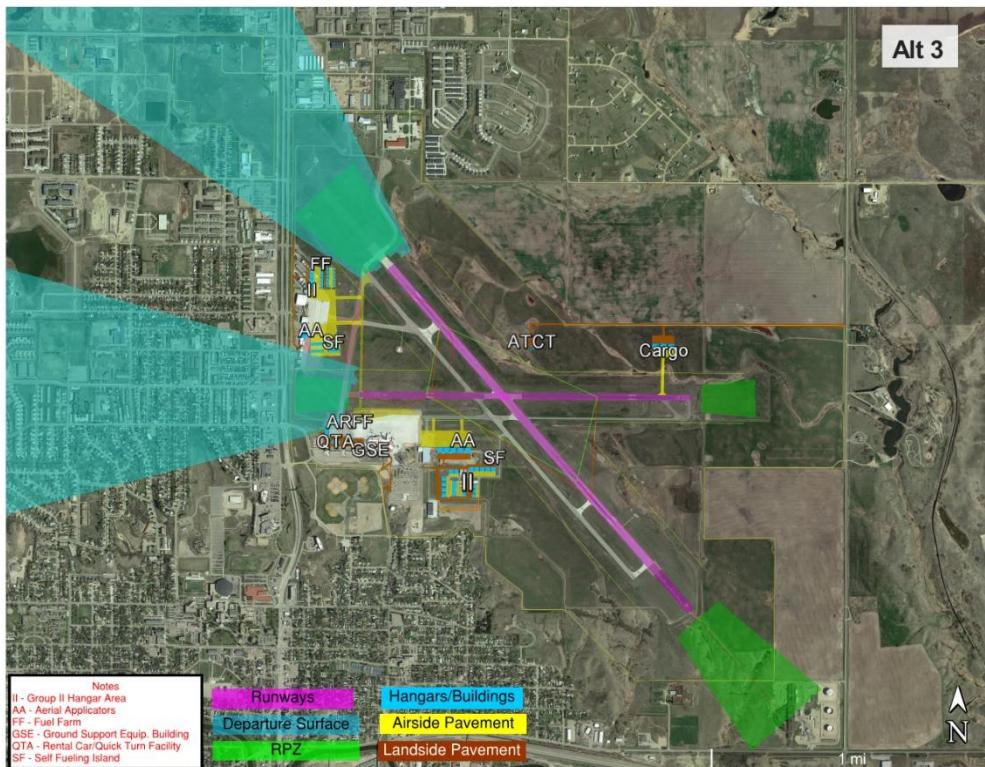
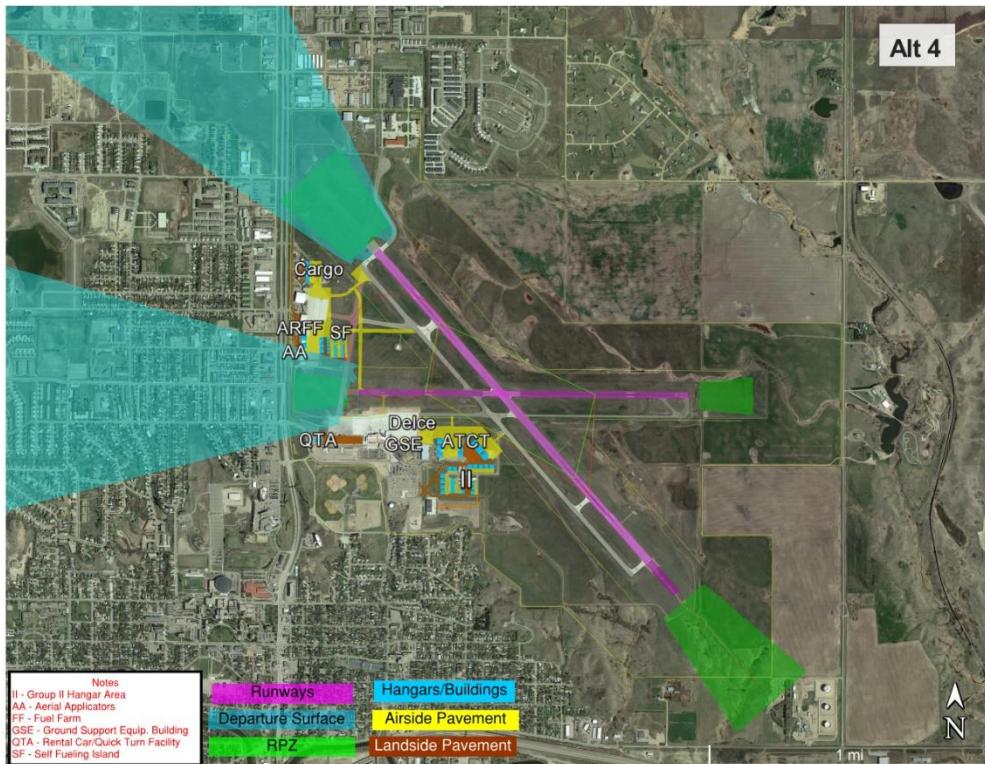
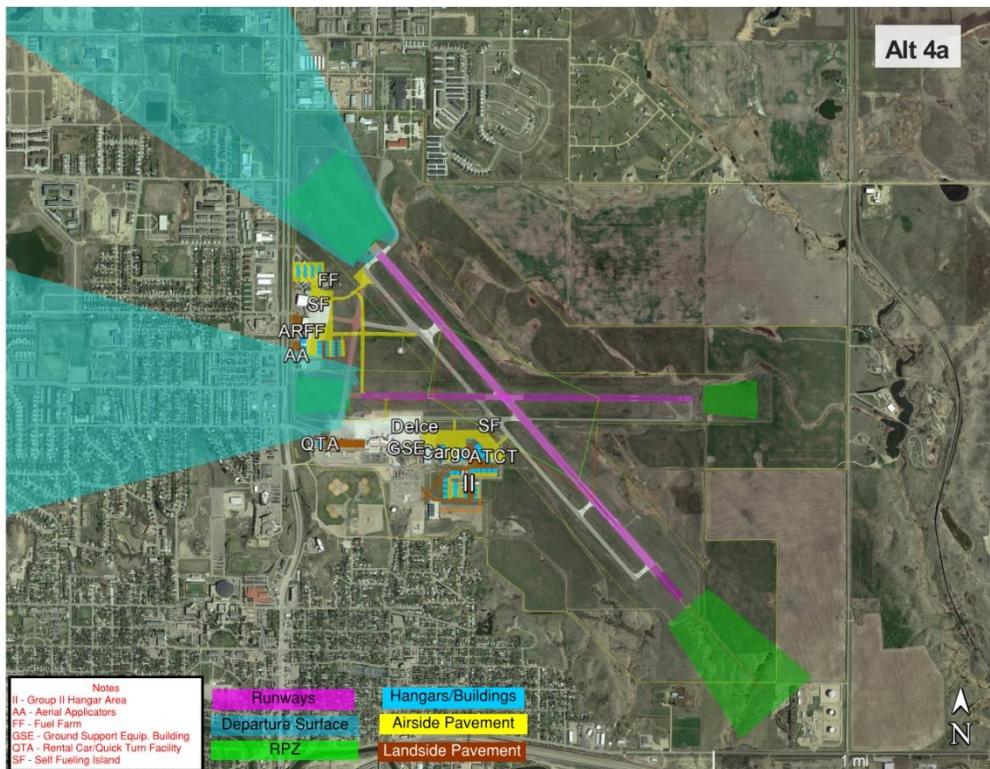
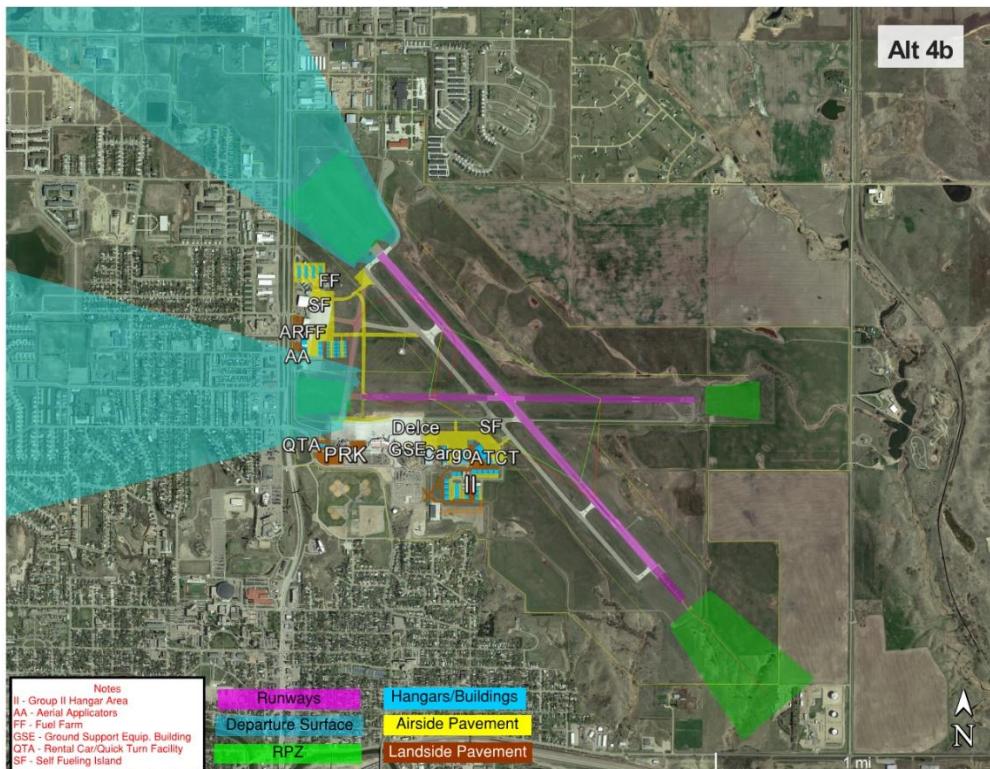
June 2016 Alternatives

June 2016 (presented to Airport Staff)
pages R-3 to R-19

Airfield 1, 2, 3, 4, 4a, 4b, 5, 5a, 5b
East 1, 2, 3
South 1, 2, 3, 4, 5, 5a
Terminal 1, 2, 3, 4, 4b, 5
West 1, 2, 3, 4, 4a, 4b, 5, 5a, 5b

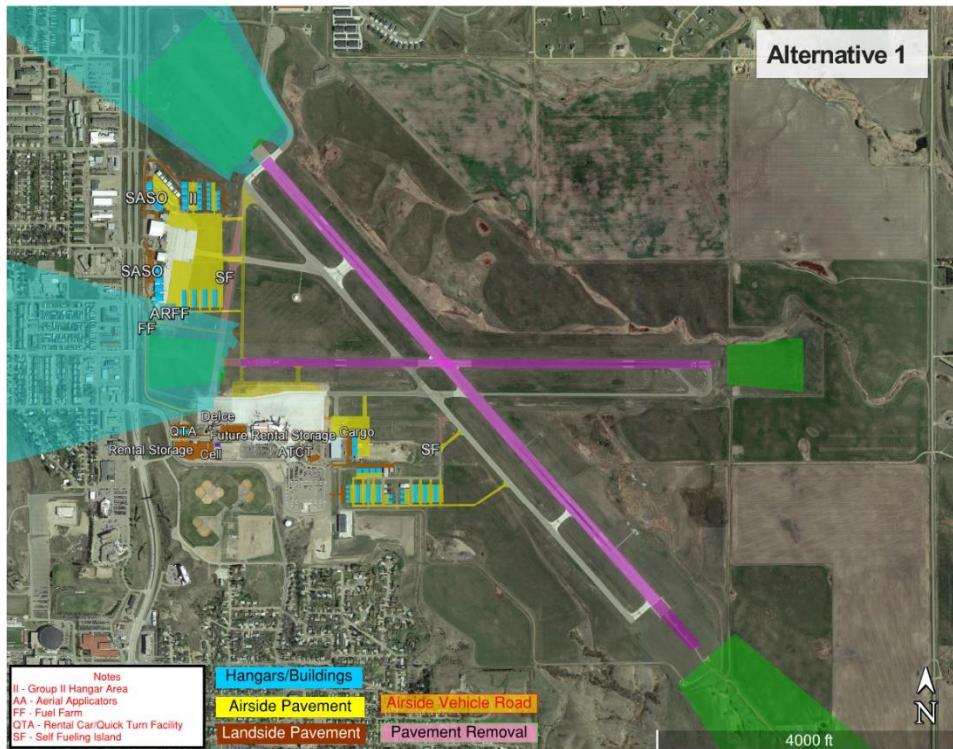
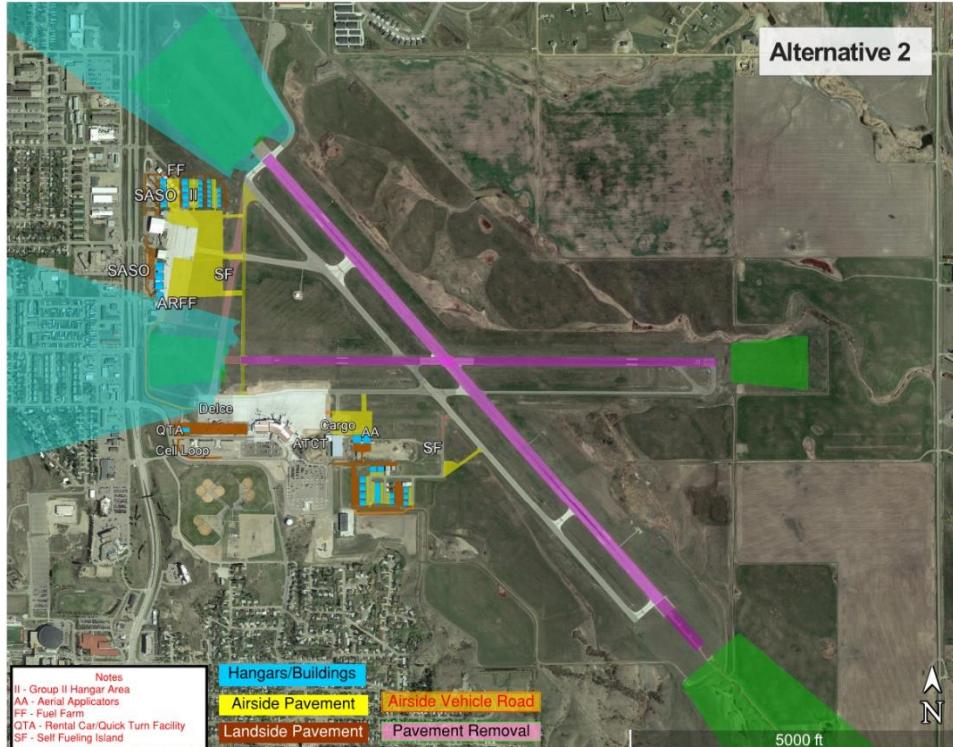
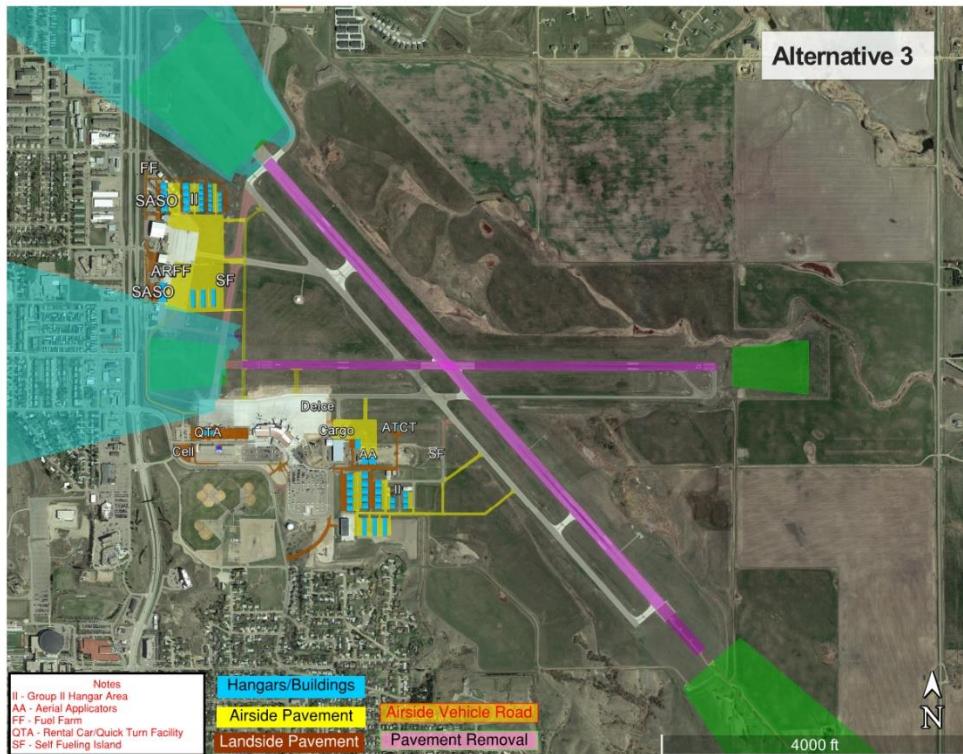
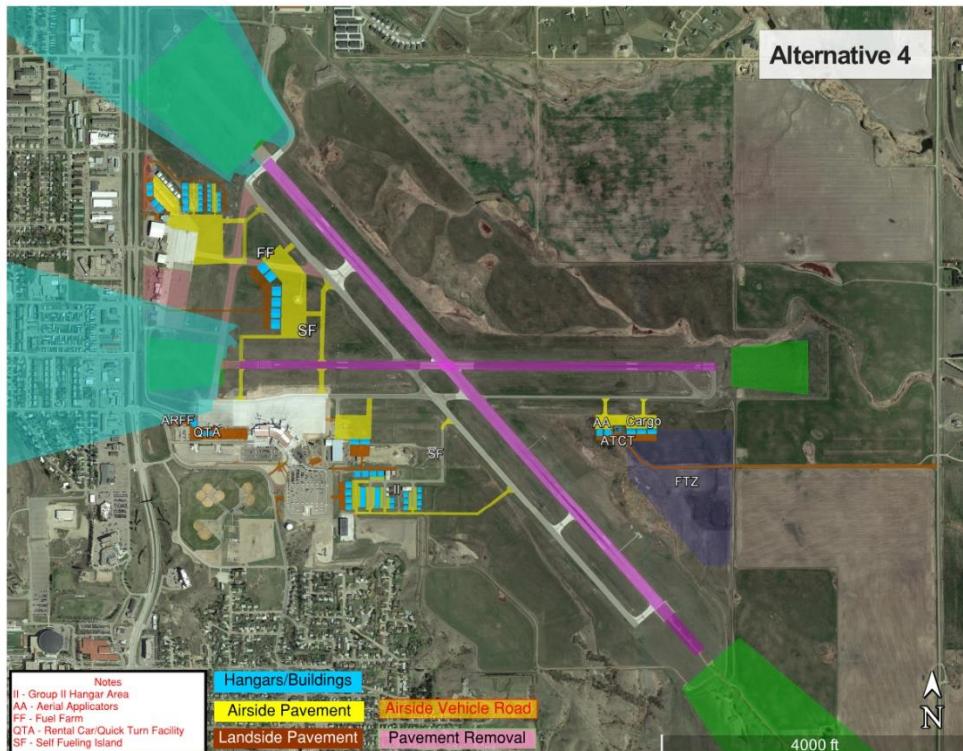
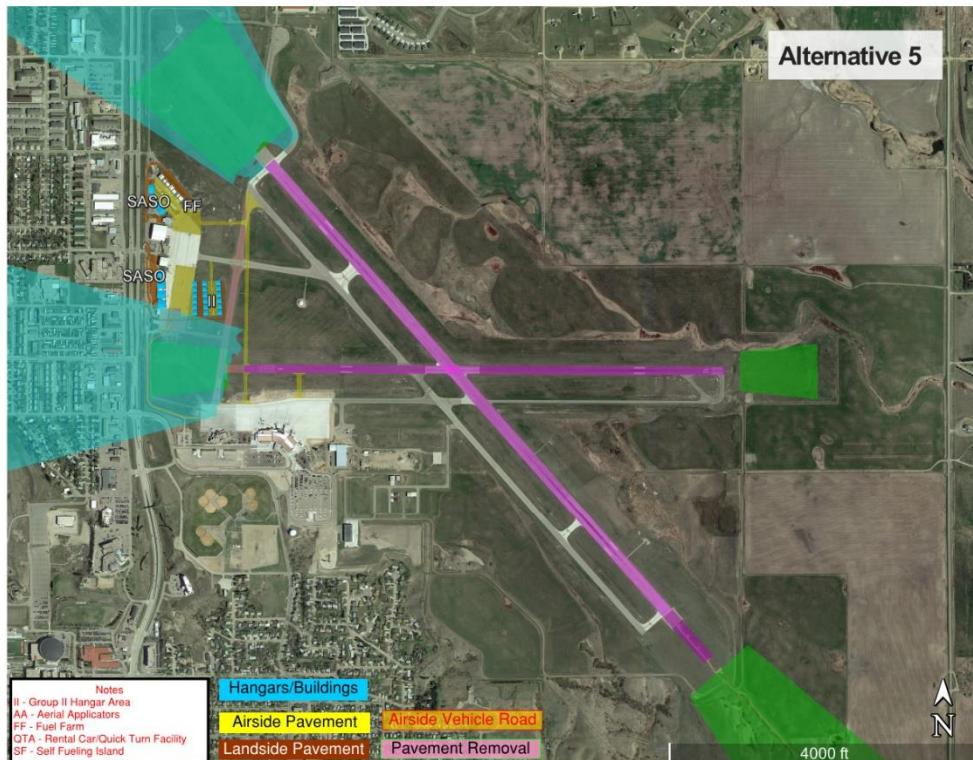
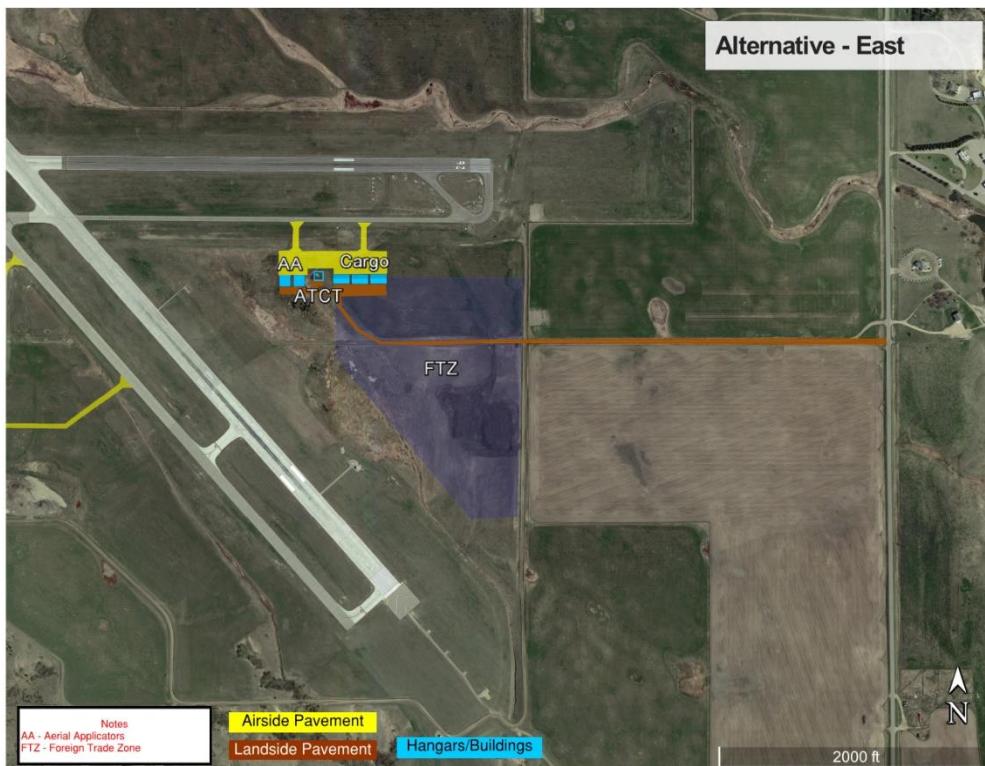
August 2016 Alternatives

August 2016 (presented to Advisory Committee)
pages R-20 to R-29

Airfield 1, 2, 3, 4, 5
East
South 1, 2, 3, 4
Terminal 1, 2, 3, 4
West 1, 2, 3, 4, 5, 5e

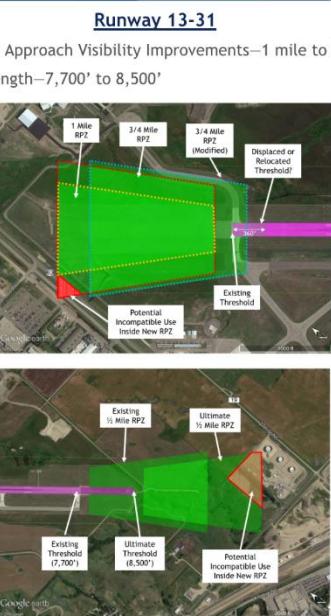
Runway 13

Runway 31

Runway 8-26

- Design Aircraft from C-III to B-II
- Relocate Runway 8 Threshold to eliminate incompatible land uses in Runway Protection Zone

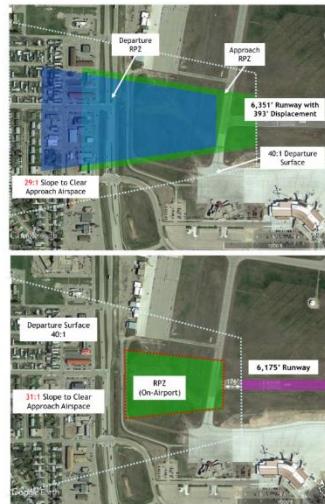
Runway 8
Existing

Runway 8
Proposed

- The Runway 8 threshold displacement may be from an FAA (AFS) recommendation to maintain a 34:1 clearance.
 - Part 77 surfaces evaluate obstruction clearance from the runway end, not the displaced threshold

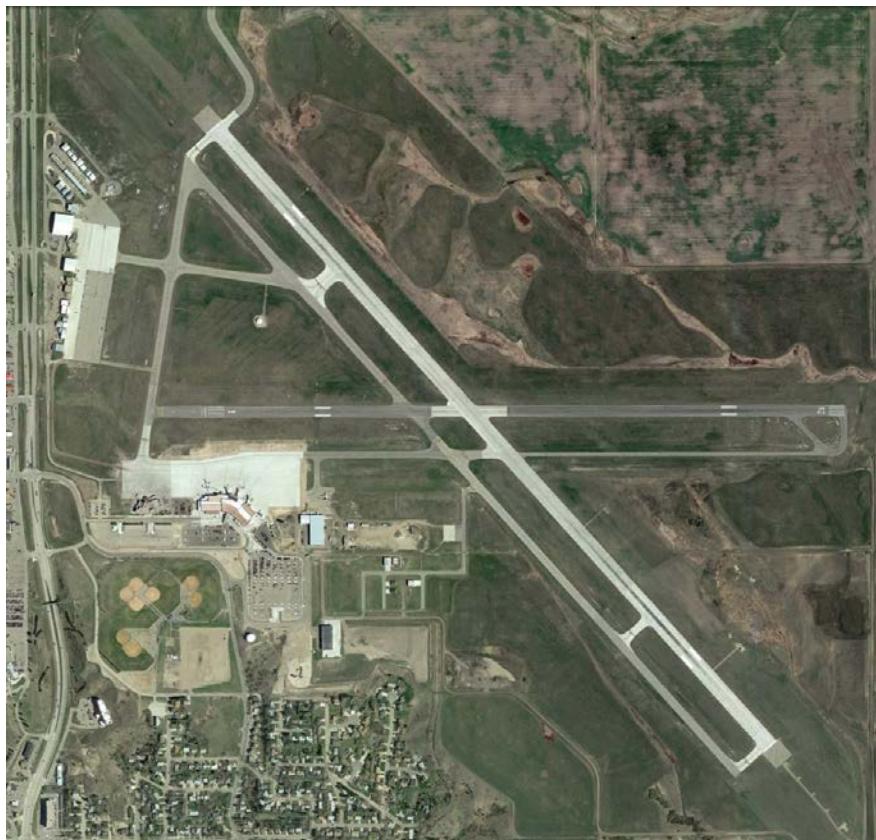
Minot International Airport - Taxiway B Design Discussion

The presentation included 11 variations of pavement design options for Runway 8 and Taxiway B. Illustrations included overlays of protected surfaces and areas affecting the designs. MOT provided its observed positive and negative features for each option.

As a follow up to the April 5, 2017 meeting, Airports Division took action to clearly identify the non-standard airfield geometry of Taxiway Bravo adjacent to the Terminal Ramp and the approach end of Runway 8. Below are the specific items that justify our position that planning efforts should be initiated to improve the geometric configuration of this particular location at the Minot International Airport. Below are the standards that FAA has found to be contrary to current FAA design standards.

With the re-write of AC 150/5300-13A, Airport Design, aligned taxiways are now prohibited and considered a non-standard airfield configuration. The FAA has found these conditions confusing to the pilots which may lead to the possible loss of situational awareness. The red arrow shown in the attached image is the true runway end based on current NASR data. The pavement prior to the runway end is considered an aligned taxiway.

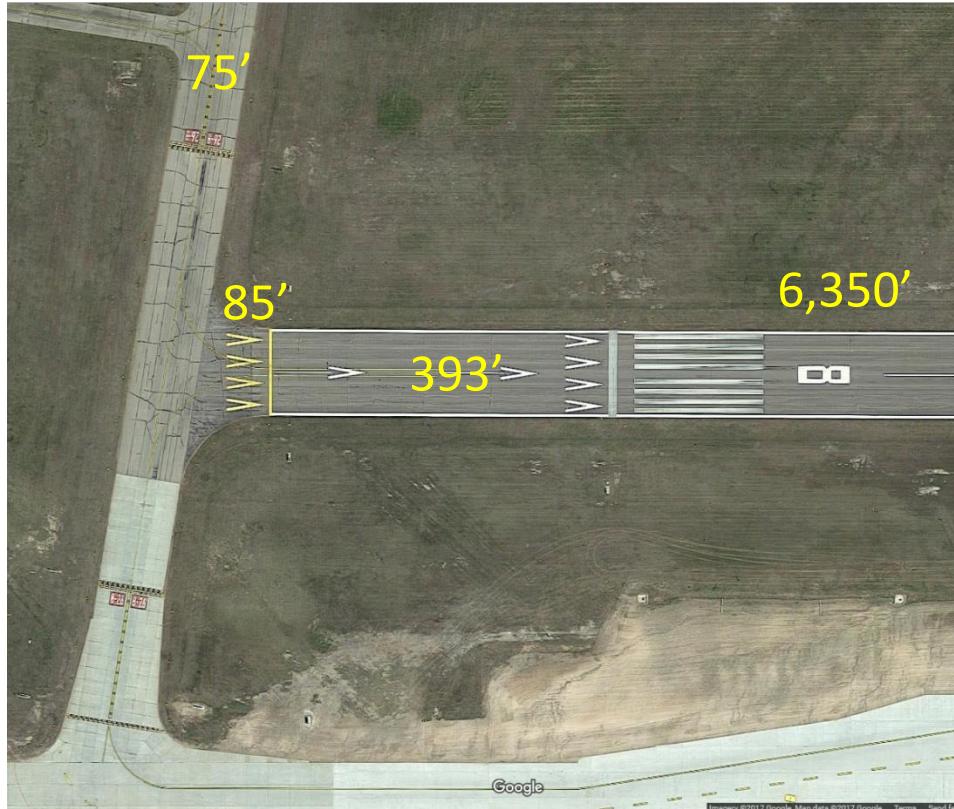
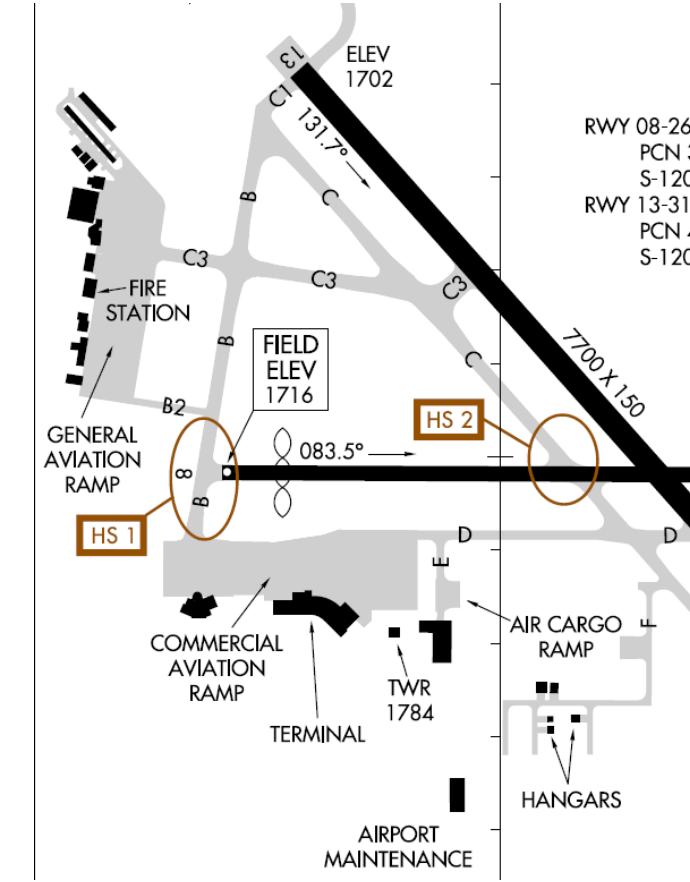
Existing TW Bravo Configuration

- Triangle Runway Configuration
- TW B and RW 8 Area Identified as Hot Spot
- RSAT Action Item to Pursue Runway Guard Lights
- Master Plan Identified as Aligned Taxiway Indicating Re-Configuration Required

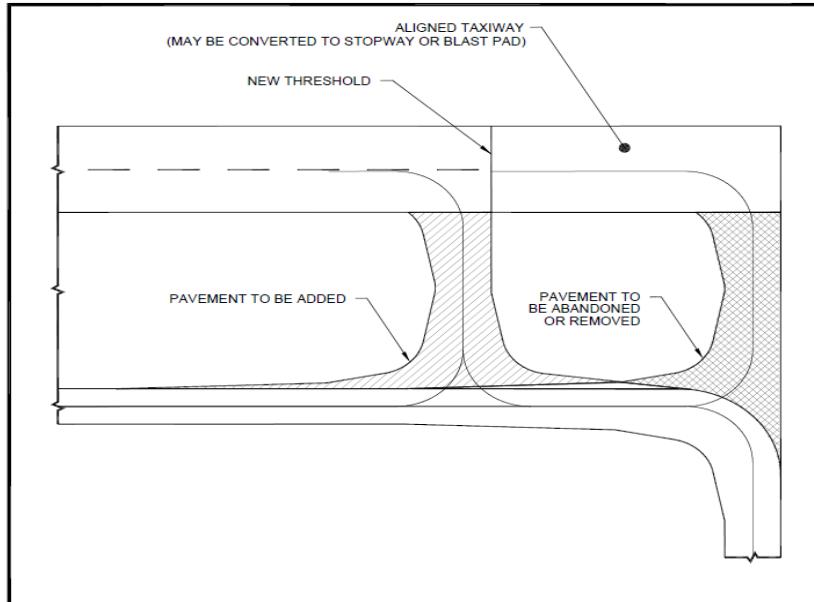
- TW centerline does not align with RW centerline
- Taxiing AC not in direct line with AC landing or taking off
- RW 8 may still be utilized per hold positions
- Limited loss of situational awareness due to turns pilots must make

An aligned taxiway is one whose centerline coincides with a runway centerline. Such taxiways have often been established due to the relocation of a runway end without constructing a new entrance taxiway at the new threshold. This places a taxiing aircraft in direct line with aircraft landing or taking off. The resultant inability to use the runway while the taxiway is occupied, along with the possible loss of situational awareness by a pilot, preclude the design of these taxiways. Existing aligned taxiways should be removed as soon as practicable. Any abandoned pavement should preferably be removed, but at a minimum appropriately marked. See [Figure 4-32](#).

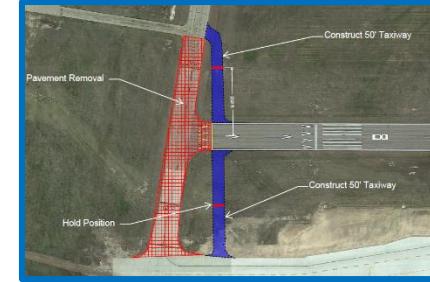
Apron locations that allow direct access onto a runway are not recommended. The apron layout should allow the design of taxiways in a manner that promotes good situational awareness by forcing pilots to consciously make turns (Figure 4-3). Taxiways originating from aprons and forming a straight line across runways are not recommended. Proper placement of aprons contributes to better accessibility, efficient aircraft movement and reduction in poor situational awareness conditions. Refer to Chapter 4 for a detailed discussion on taxiway designs that are not recommended, as discussed below, such as:

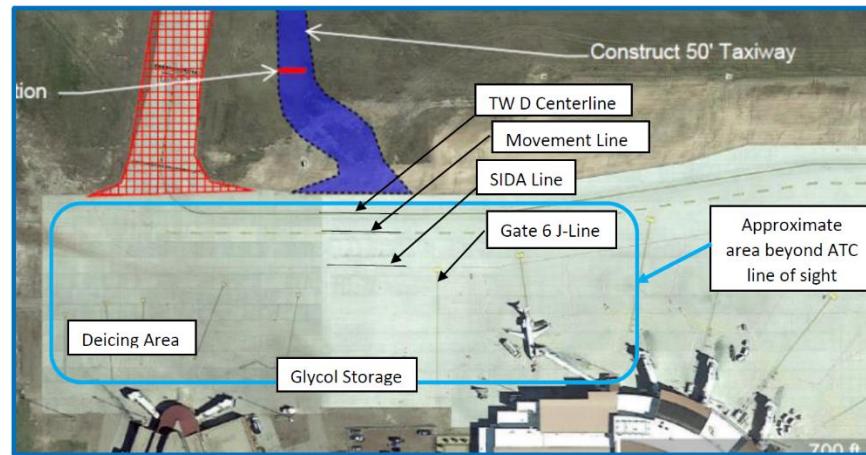
→ Depth of Commercial Ramp Regarding Alternate Taxiway Configuration

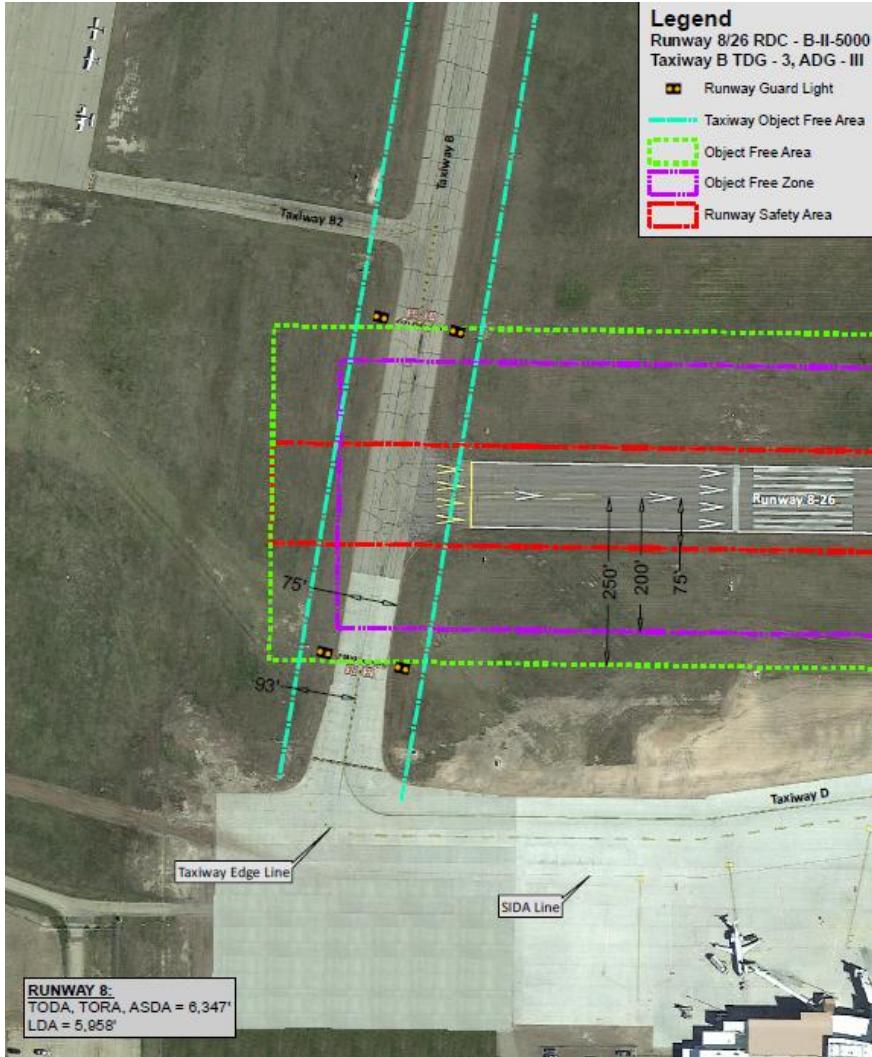
TW Bravo Option 1

- FAA Design Standards**
 - Aligned Taxiway
- Increased Safety/Hot Spot Mitigation**
 - Better Visibility
 - No Runway Crossing
- Operational Efficiency**
 - TW Routes Maintained
 - No Impact to Ramp Operations
- Cost - \$58,025**

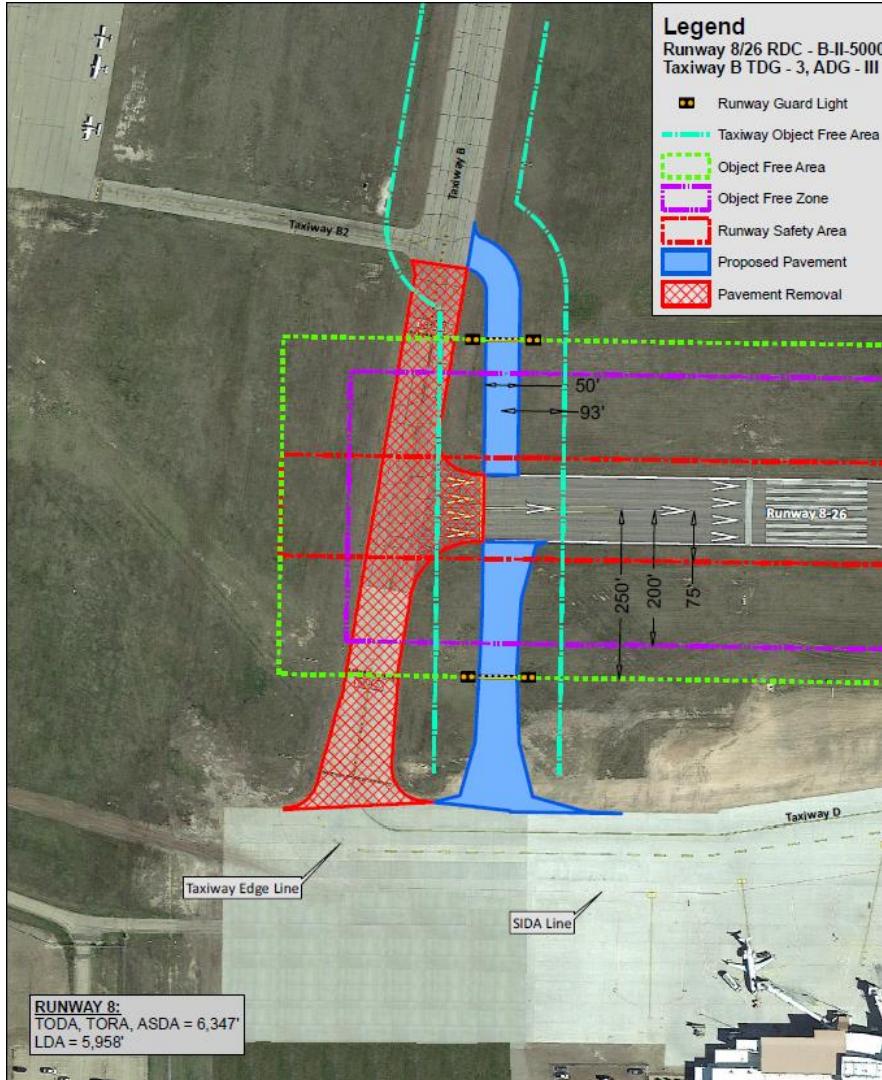
TW Bravo Option 2

- ✖ **FAA Design Standards**
 - Direct Access
- ✖ **Increased Safety/Hot Spot Mitigation**
 - Loss of Situational Awareness from Ramp
 - Creates Runway Crossing
- ✖ **Operational Efficiency**
 - Potential for Congested Ramp Operations (250' closer)
- **Cost - \$755,000**

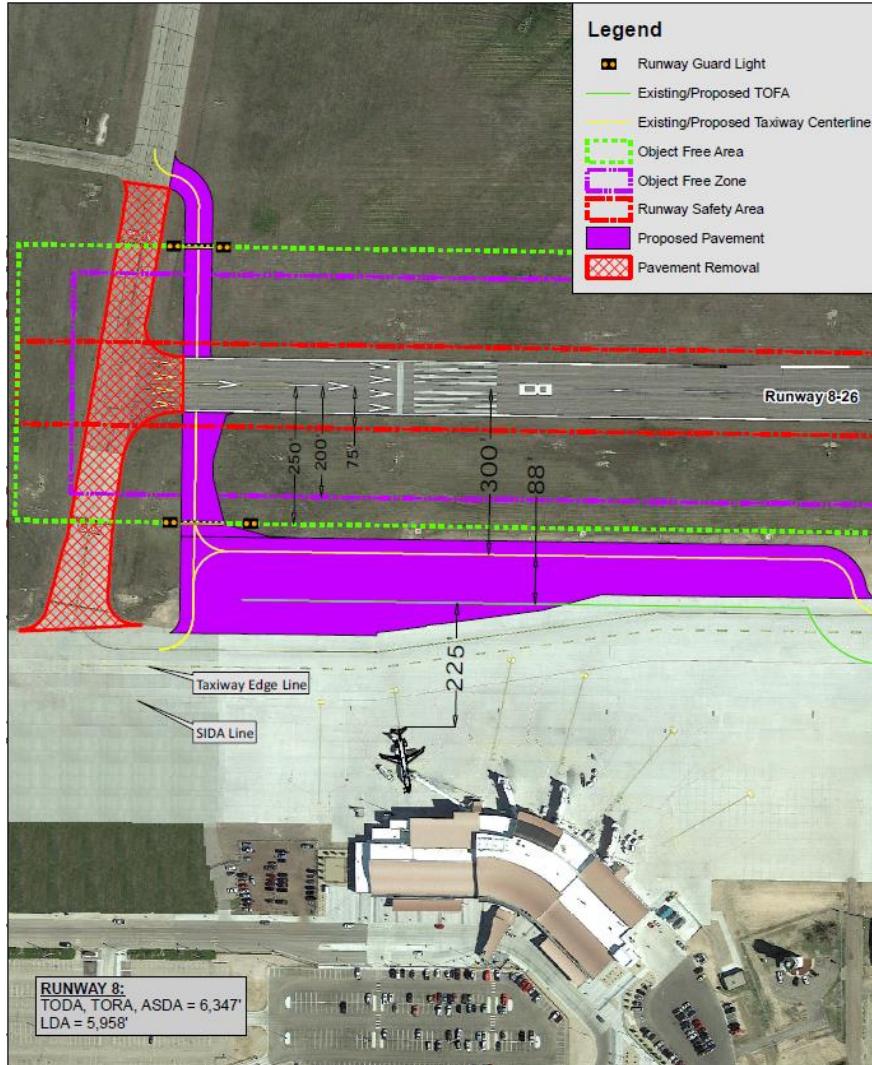
TW Bravo Option 2 Large

- ✖ **FAA Design Standards**
 - Direct Access
- ✖ **Increased Safety/Hot Spot Mitigation**
 - Potential Loss of Situational Awareness
 - Creates Runway Crossing
- **Operational Efficiency**
 - Allows Greater Maneuverability on Ramp

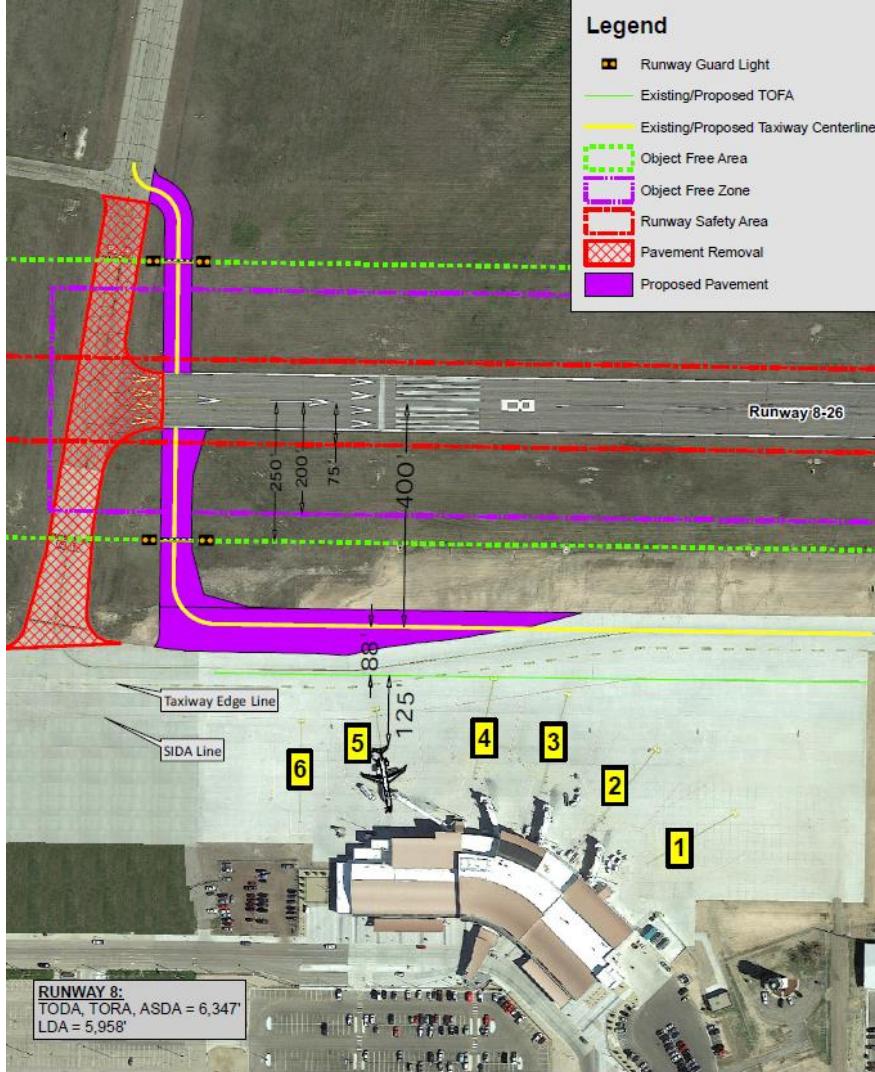
TW Bravo Option 2 Small

- ✖ **FAA Design Standards**
 - Direct Access
- ✖ **Increased Safety/Hot Spot Mitigation**
 - Potential Loss of Situational Awareness
 - Creates Runway Crossing
- **Operational Efficiency**
 - Allows Some Maneuverability on Ramp

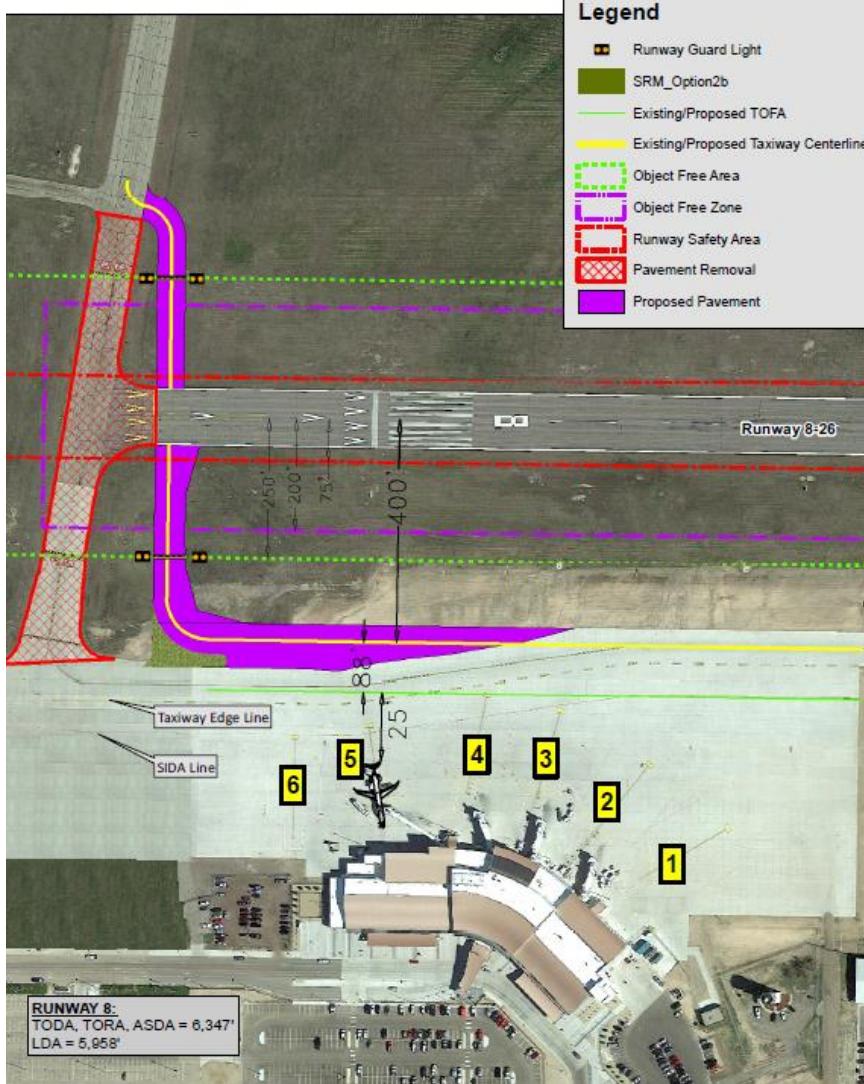
TW Bravo Option 2b (FAA)

- **FAA Design Standards**
 - No Direct Access
- ✖ **Increased Safety/Hot Spot Mitigation**
 - Creates Runway Crossing
 - Head On Opposing Aircraft Taxiing
- ✖ **Operational Efficiency**
 - Congested Ramp Operations
 - Turn from West

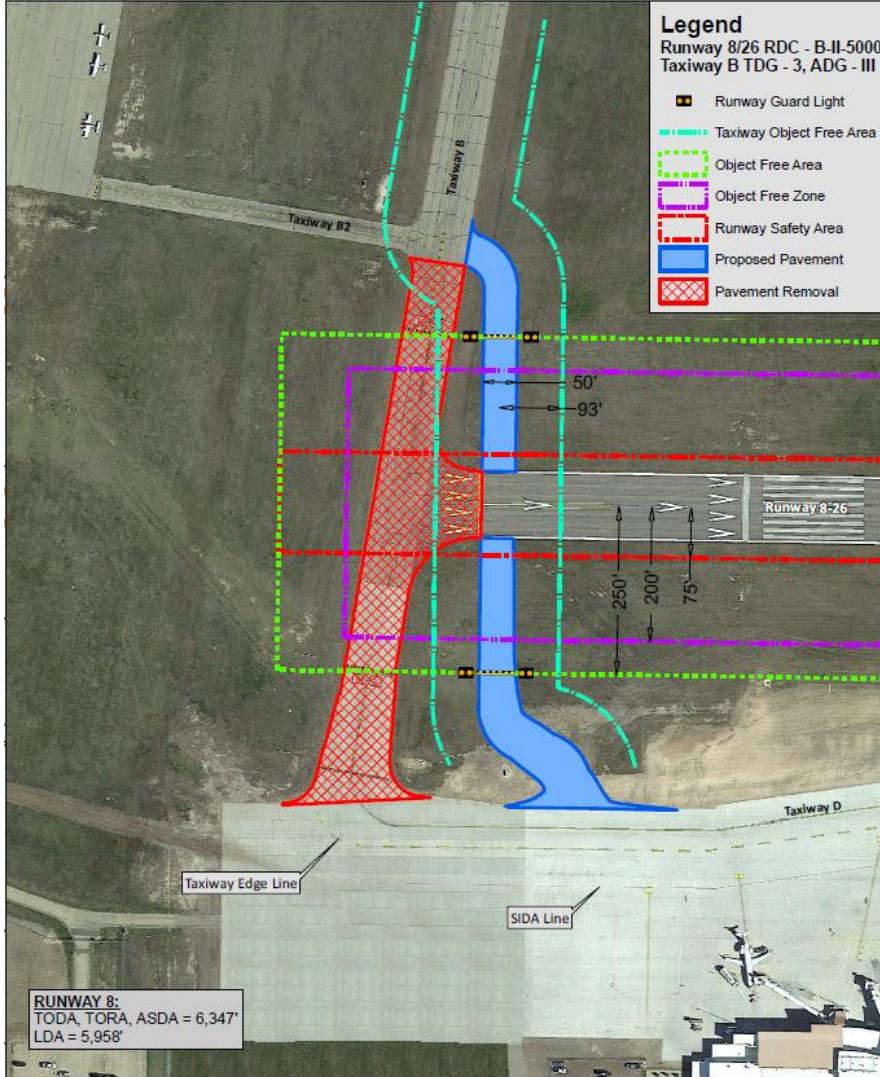
TW Bravo Option 3

- **FAA Design Standards**
 - No Direct Access
 - No Aligned TW
- ✖ **Increased Safety/Hot Spot Mitigation**
 - Creates Runway Crossing
- ✖ **Operational Efficiency**
 - Congested Ramp Operations (380' Closer)
- **Cost - \$910,800**

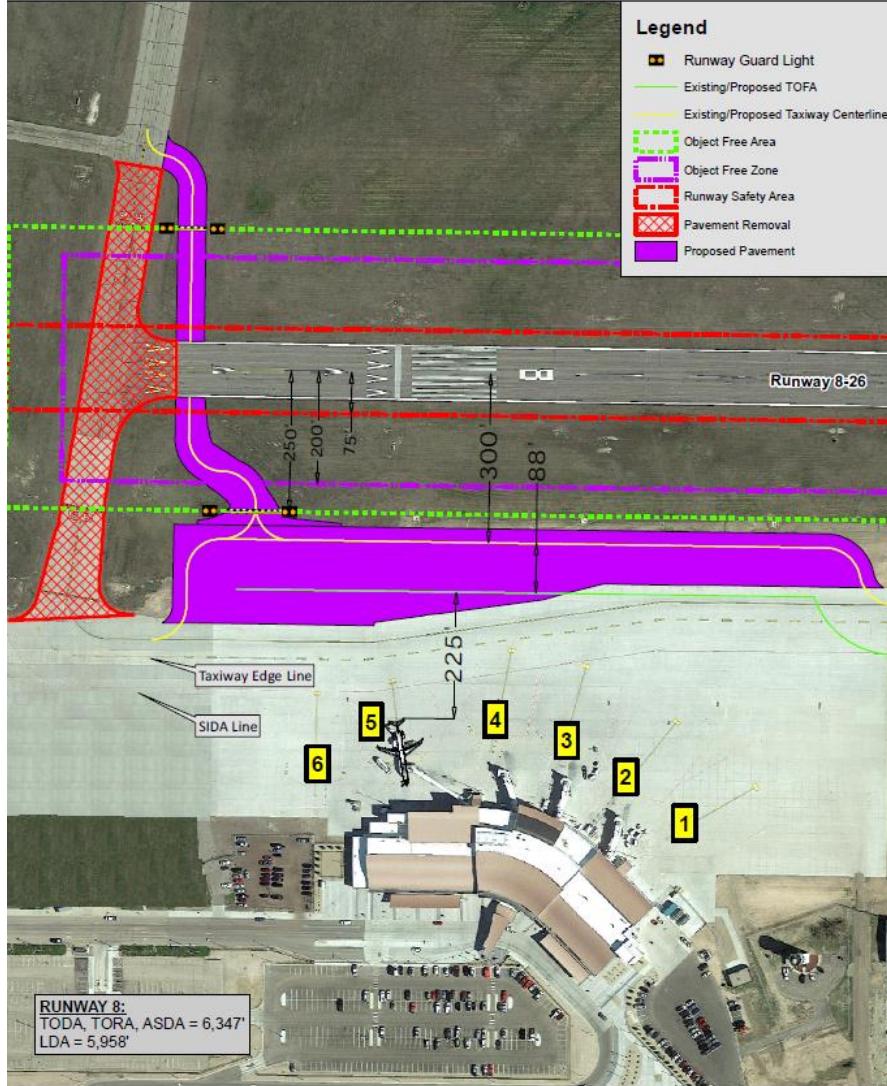
TW Bravo Option 3 Large

- **FAA Design Standards**
 - No Direct Access
 - No Aligned TW
- ✖ **Increased Safety/Hot Spot Mitigation**
 - Creates Runway Crossing
 - Potential Bottlenecking?
- **Operational Efficiency**
 - Allows Greater Maneuverability on Ramp

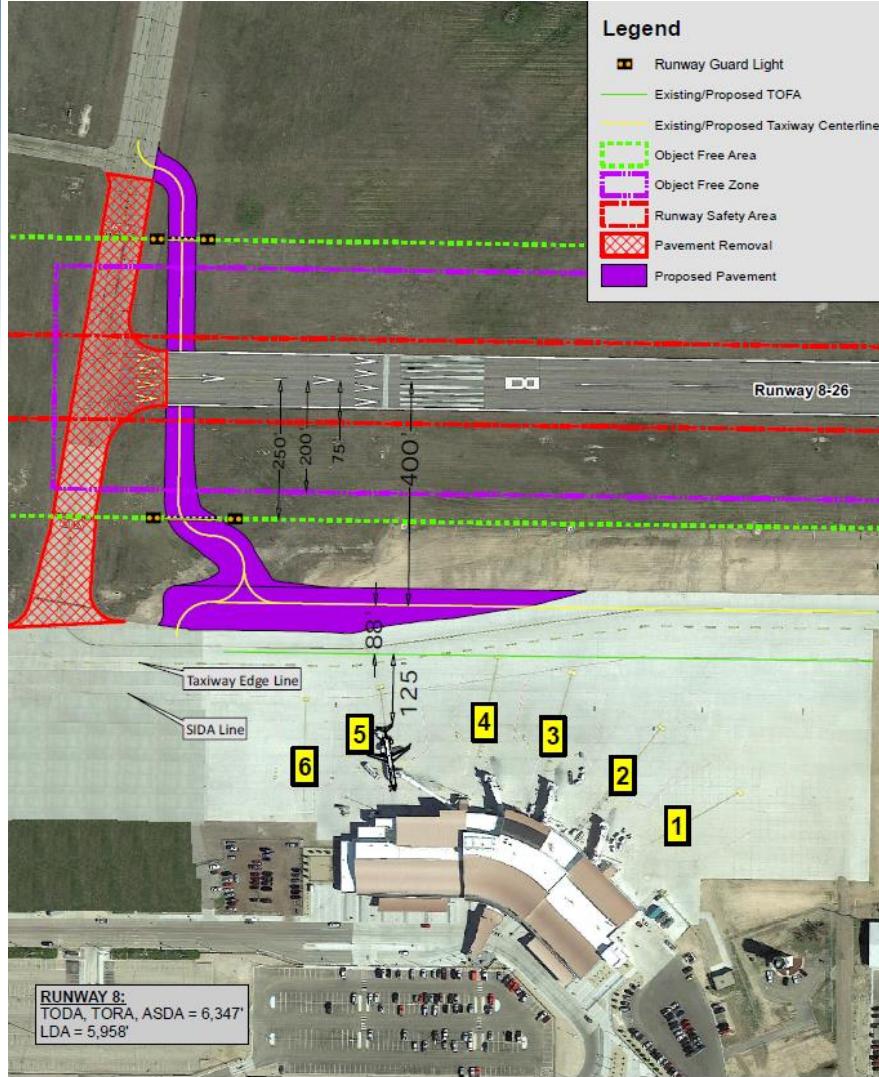
TW Bravo Option 3 Small

- **FAA Design Standards**
 - No Direct Access
 - No Aligned TW
- ✖ **Increased Safety/Hot Spot Mitigation**
 - Creates Runway Crossing
- **Operational Efficiency**
 - Allows Some Maneuverability on Ramp
