APPENDIX R - ALTERNATIVES

Because there were a substantial number of alternatives prepared for the Minot International Airport Master Plan process, this appendix provides a copy of those alternatives by area and time sequence. The analysis and decisions related to alternatives are provided in **Chapter 5: Alternatives Analysis**.

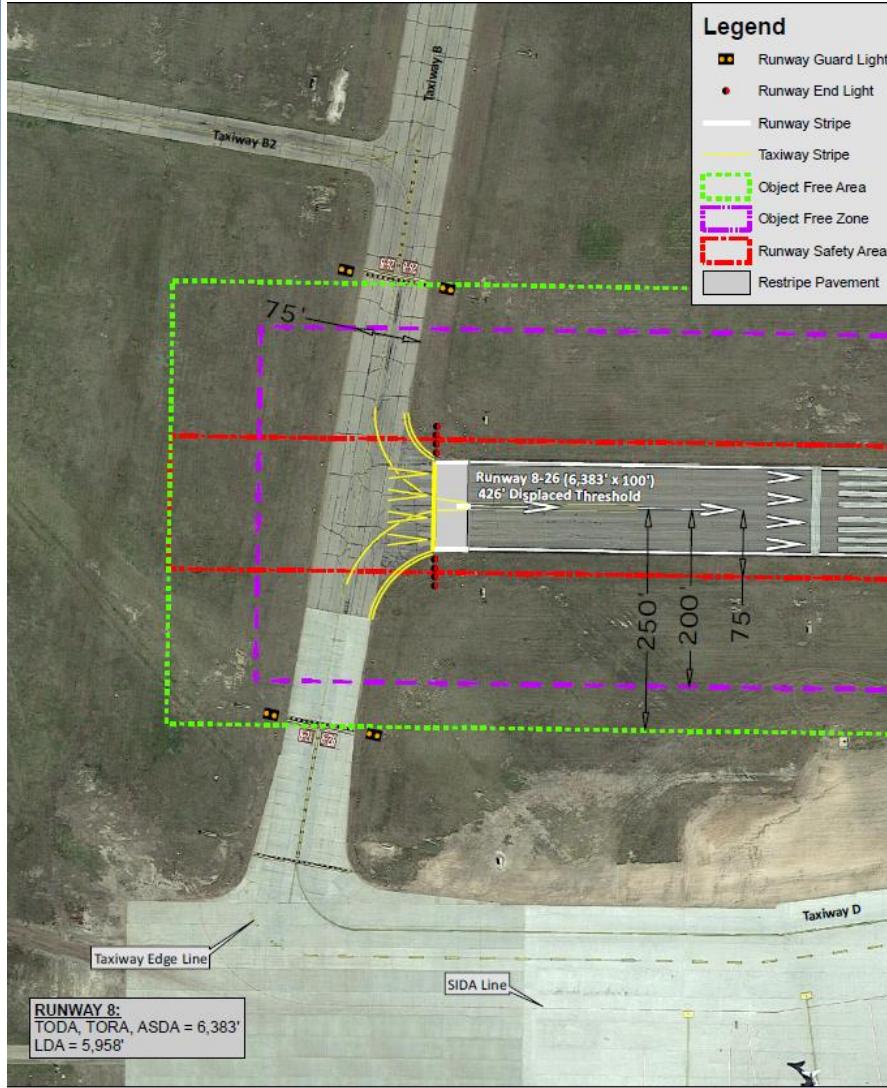
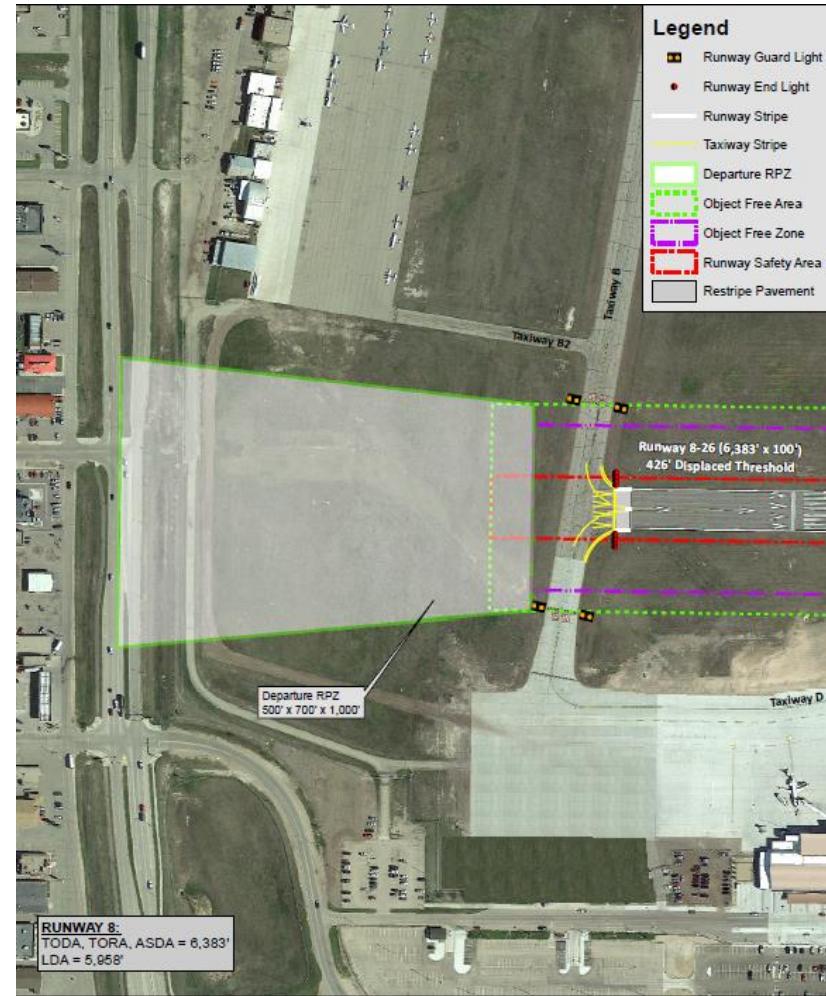
TW Bravo Option 4 with RPZ

TW Bravo Option 4 (Standard)

- ☒ **FAA Design Standards**
 - Aligned Taxiway
 - Non-Perpendicular
- **Increased Safety/Hot Spot**
Mitigation
 - Better Visibility
 - No Runway Crossing
- **Operational Efficiency**
 - TW Routes Maintained
 - No Impact to Ramp Operations
- **Cost - \$128,495**

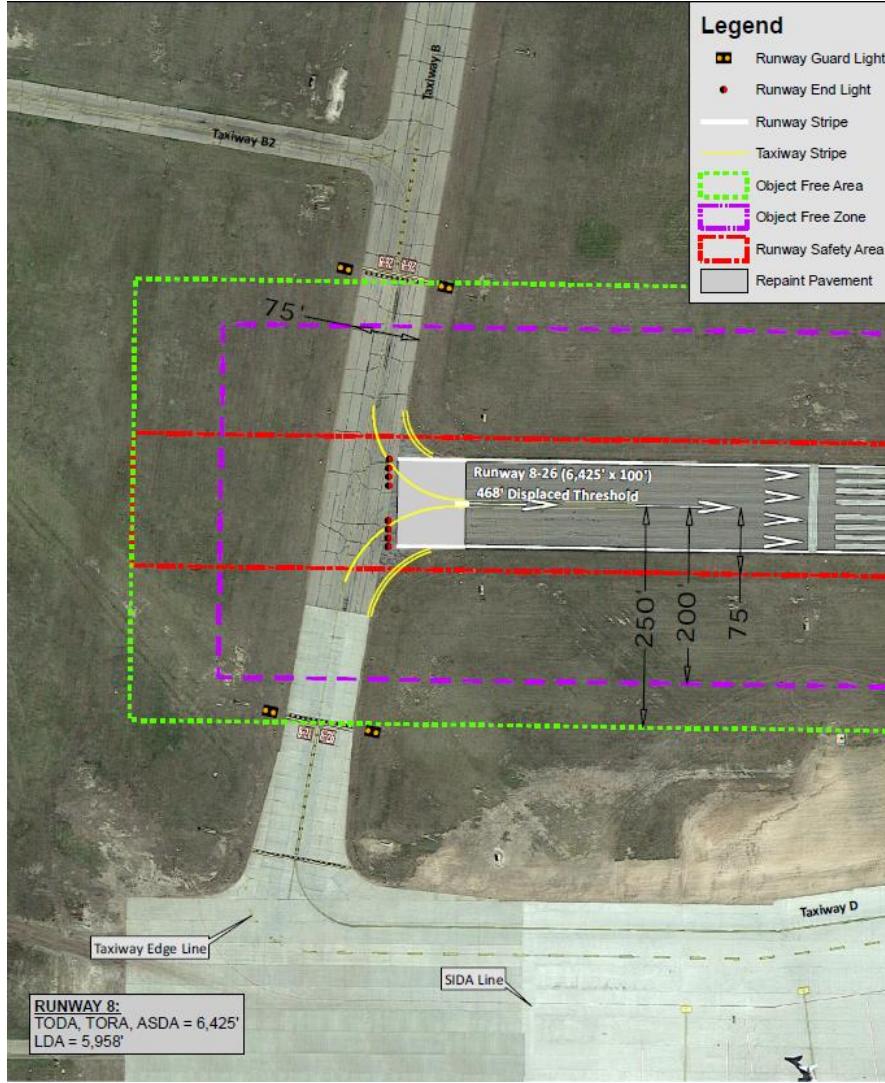
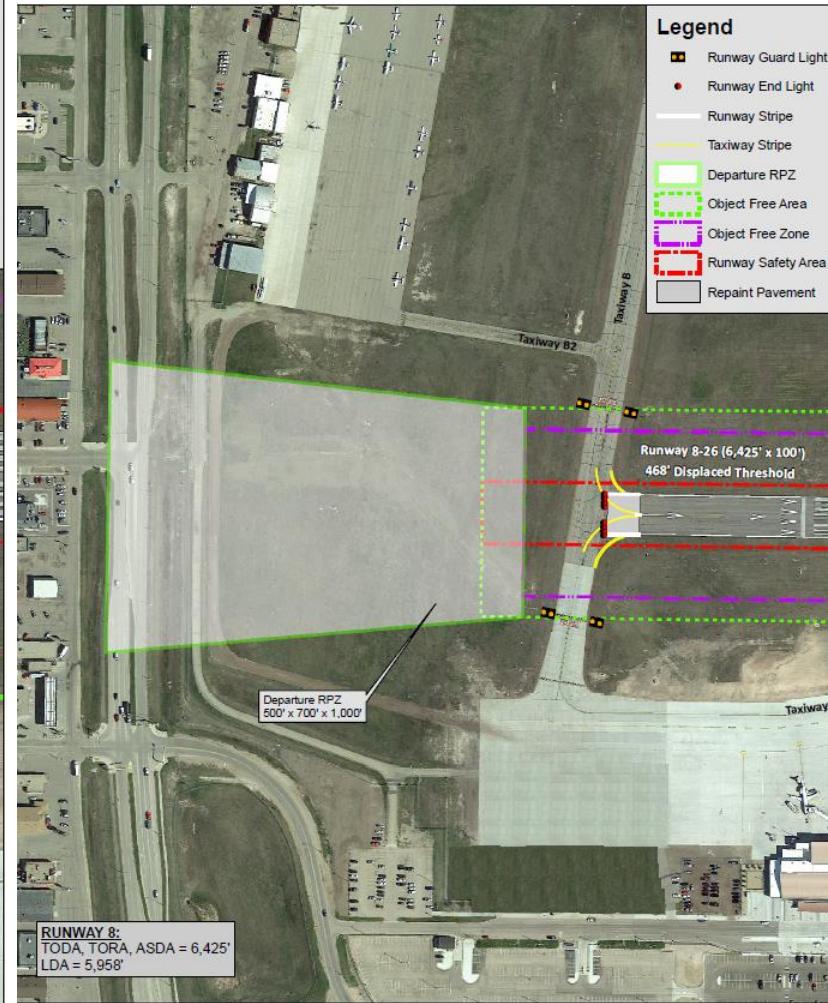
TW Bravo Option 4b with RPZ

TW Bravo Option 4b (In Pavement)

- ☒ **FAA Design Standards**
 - Aligned Taxiway
 - Non-Perpendicular
- **Increased Safety/Hot Spot Mitigation**
 - Better Visibility
 - No Runway Crossing
- **Operational Efficiency**
 - TW Routes Maintained
 - No Impact to Ramp Operations
- **Cost - \$135,495**

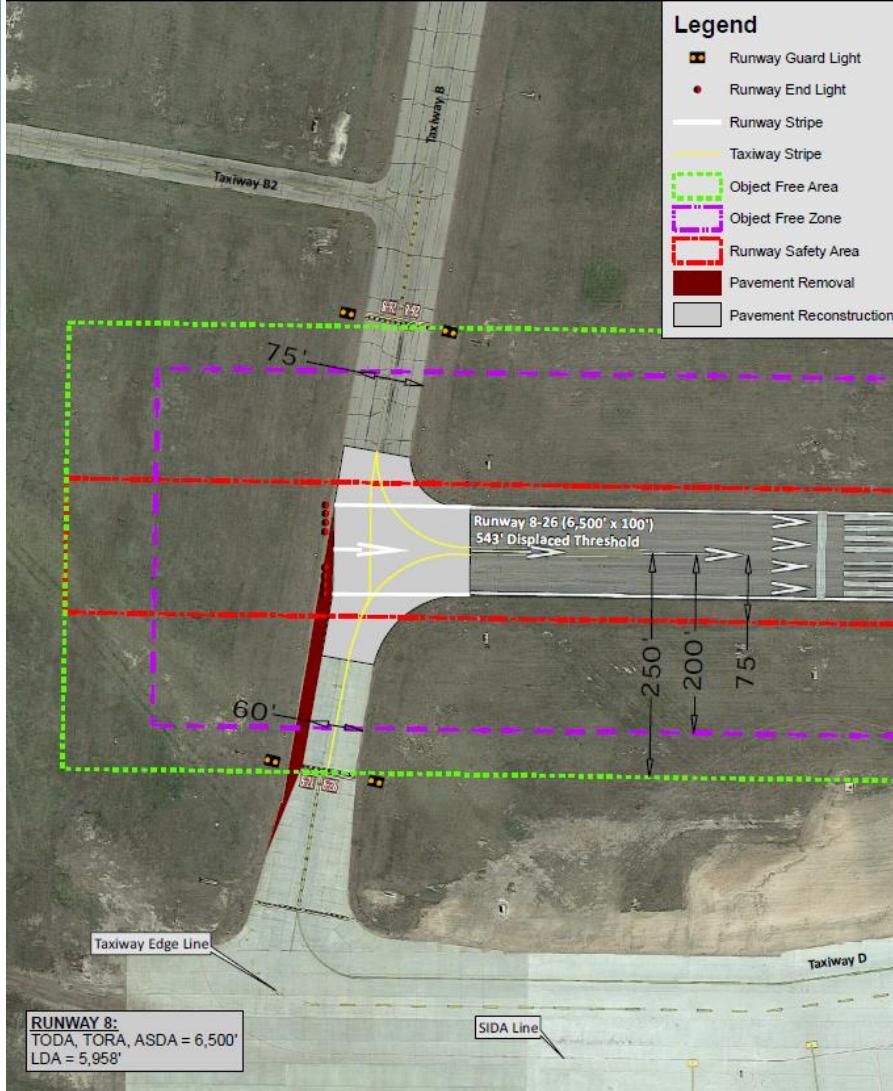
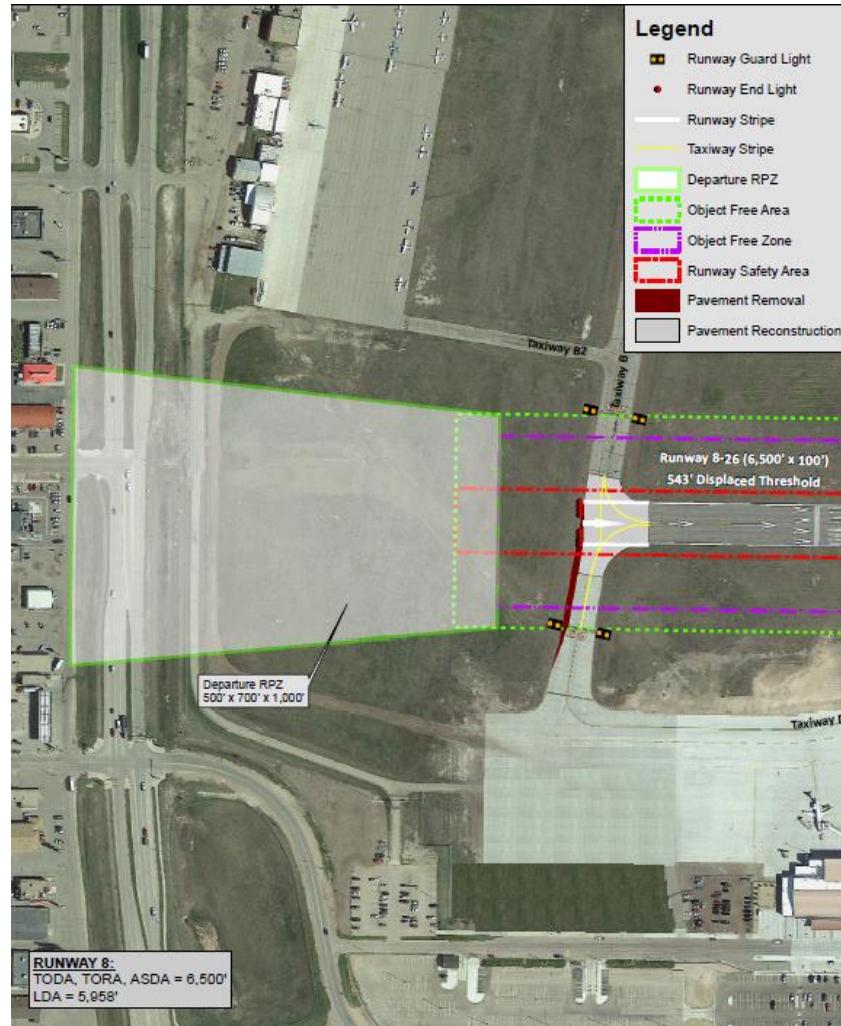
TW Bravo Option 5 with RPZ

- FAA Design Standards**
 - Non-Perpendicular
 - RPZ Control
- Increased Safety/Hot Spot Mitigation**
 - Creates Runway Crossing
- Operational Efficiency**
 - TW Routes Maintained
 - No Impact to Ramp Operations
- Cost - \$556,890**

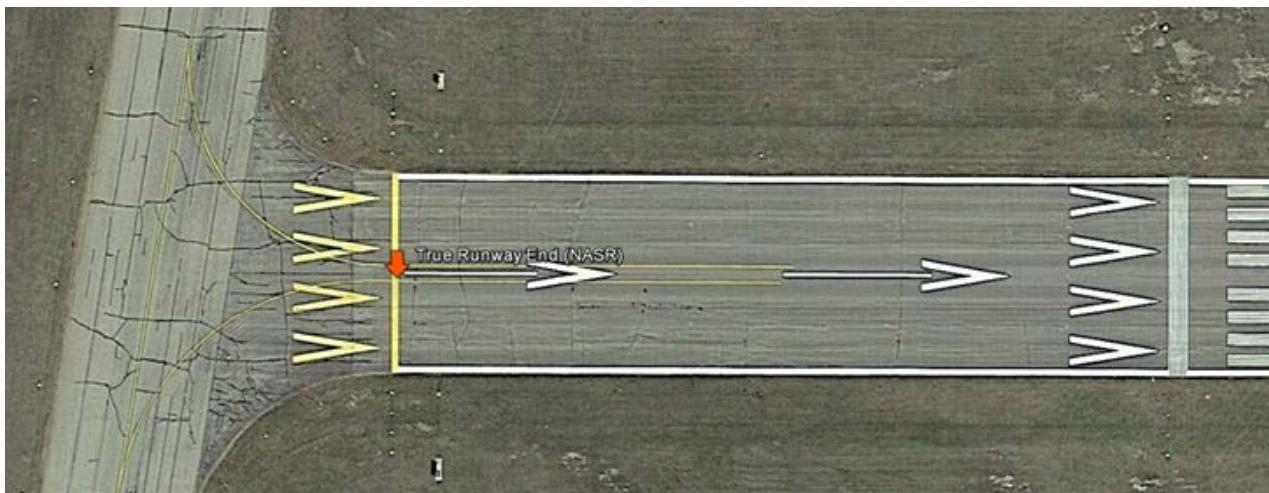
1. Aligned Taxiway

With the re-write of AC 150/5300-13A, Airport Design, aligned taxiways are now prohibited and considered a non-standard airfield configuration. The FAA has found these conditions confusing to the pilots which may lead to the possible loss of situational awareness. The red arrow shown in the attached image is the true runway end based on current NASR data. The pavement prior to the runway end is considered an aligned taxiway.

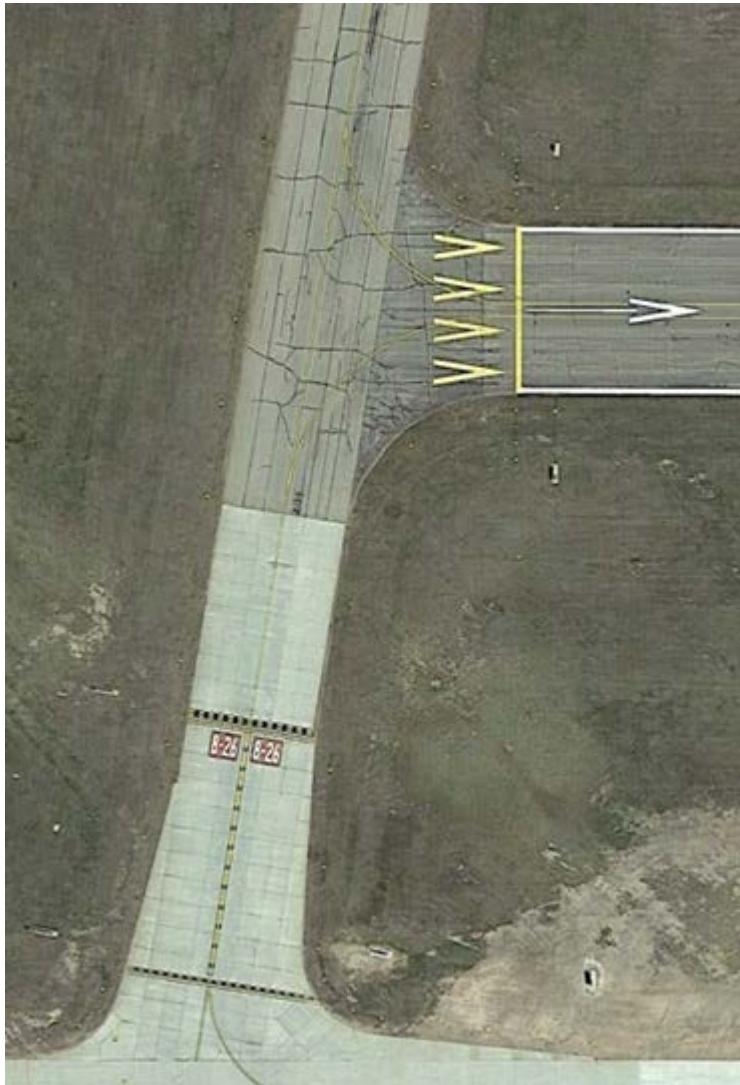
2. Runway End Taxiways

Each runway end must be served by an entrance taxiway, which are connected to the runway at a right angle. The existing configuration at MOT does not have an entrance taxiway at the true runway end, and the taxiway used to access Runway 08 is non-perpendicular. It is important for entrance taxiways to connect to runways at right angles as it allows pilots to have a clear line of sight to both ends of the runway. Having the pilot canted in one direction will result in visibility limitations. **Meeting this standard is even more important at airports such as MOT that do not have a 24-hour ATCT.**

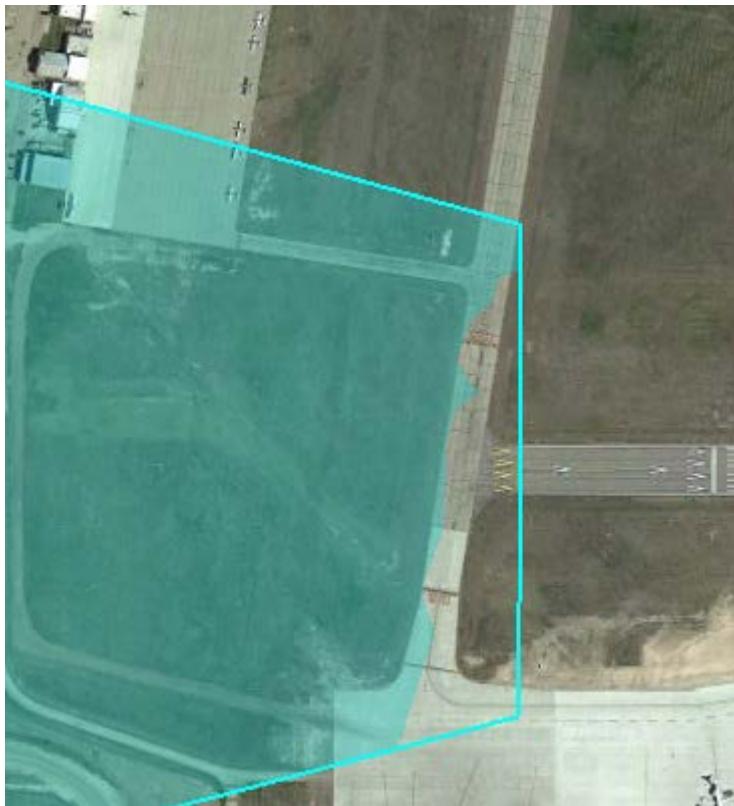
3. Departure Surface Penetrations

Runway 26 has a published departure procedure which triggers the protection of the 40:1 departure surface, shown below in blue. The departure surface begins at the end of the runway. Pavement prior to the runway end, as in this configuration, results in penetration to the departure surface when aircraft or vehicles are in that area. Removal and reconfiguration of these taxiways would ensure conformity to the standard.

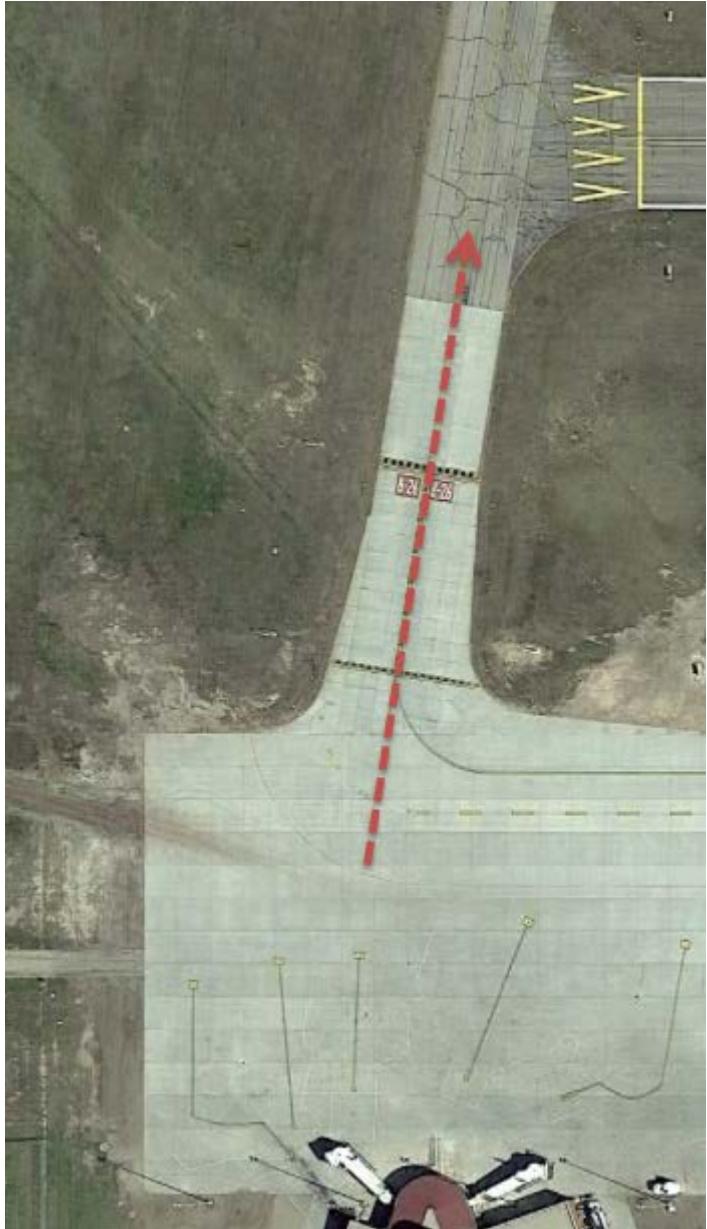
5. Indirect Access

AC 150/5300-13A, titled *“Airport Design”* specifically states not to have taxiways which lead directly from an apron to a runway without requiring a turn. The existing configuration results in direct access to the runway.
