APPENDIX R - ALTERNATIVES

Because there were a substantial number of alternatives prepared for the Minot International Airport Master Plan process, this appendix provides a copy of those alternatives by area and time sequence. The analysis and decisions related to alternatives are provided in **Chapter 5: Alternatives Analysis**.

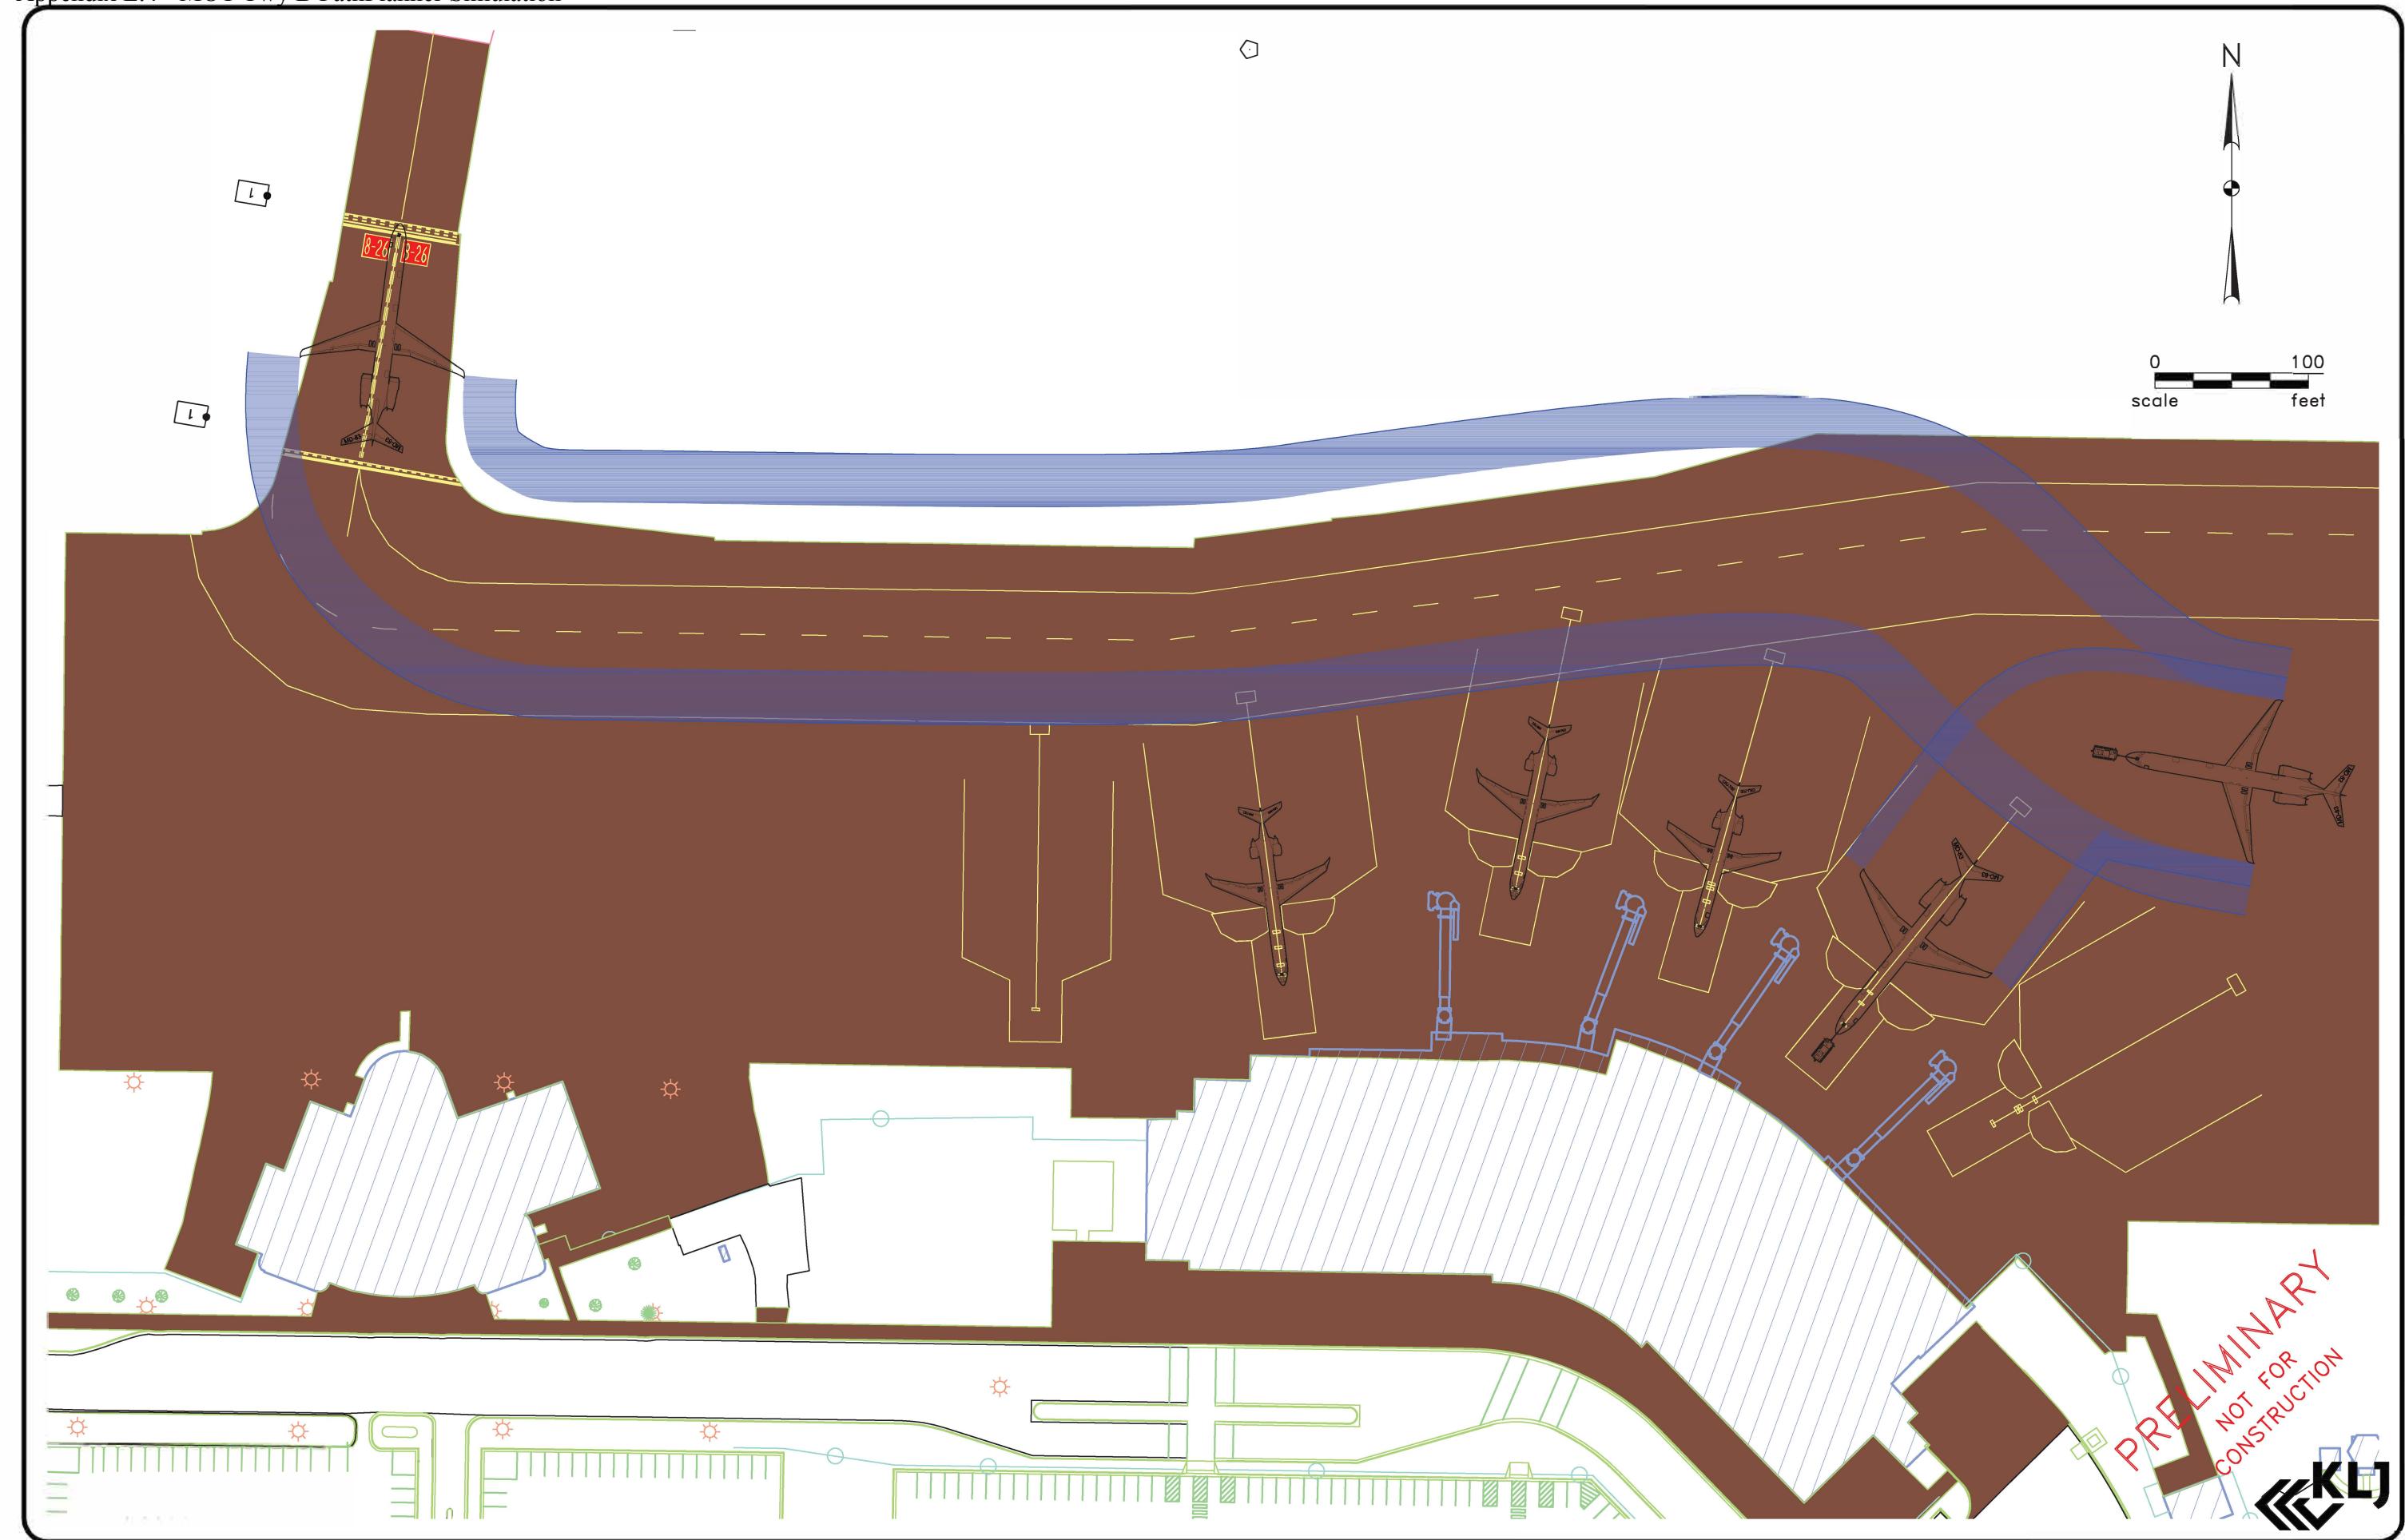
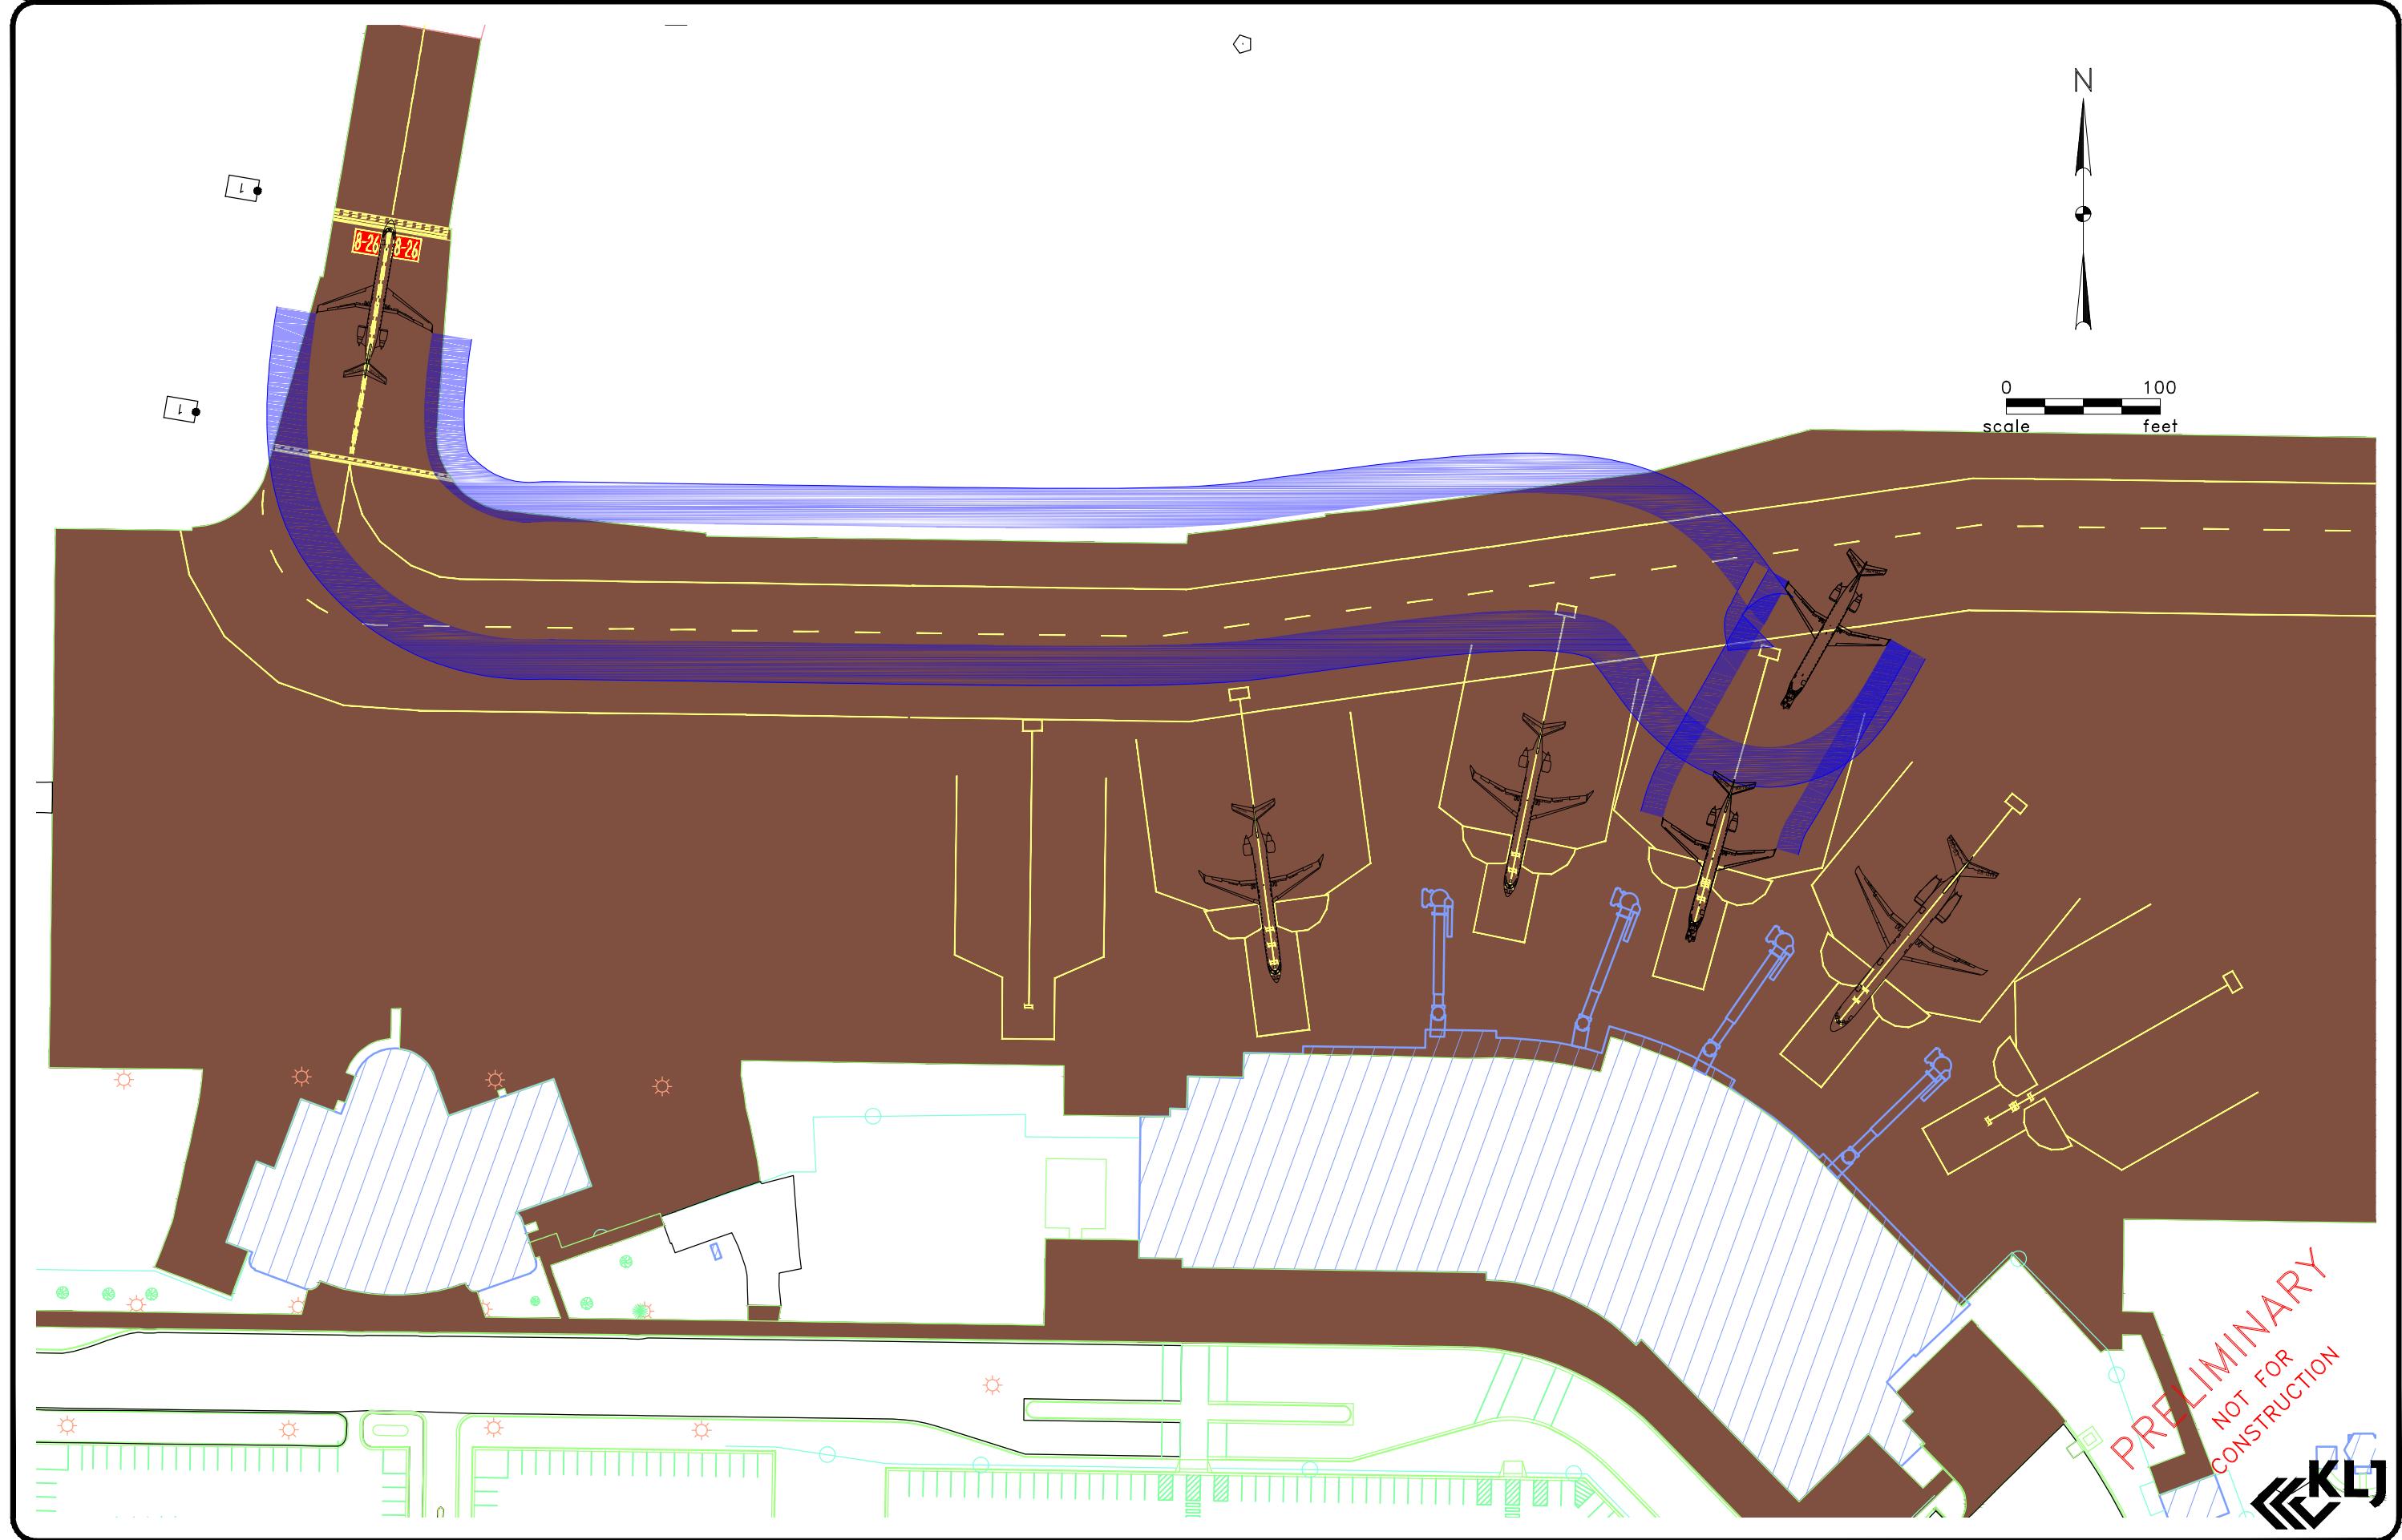
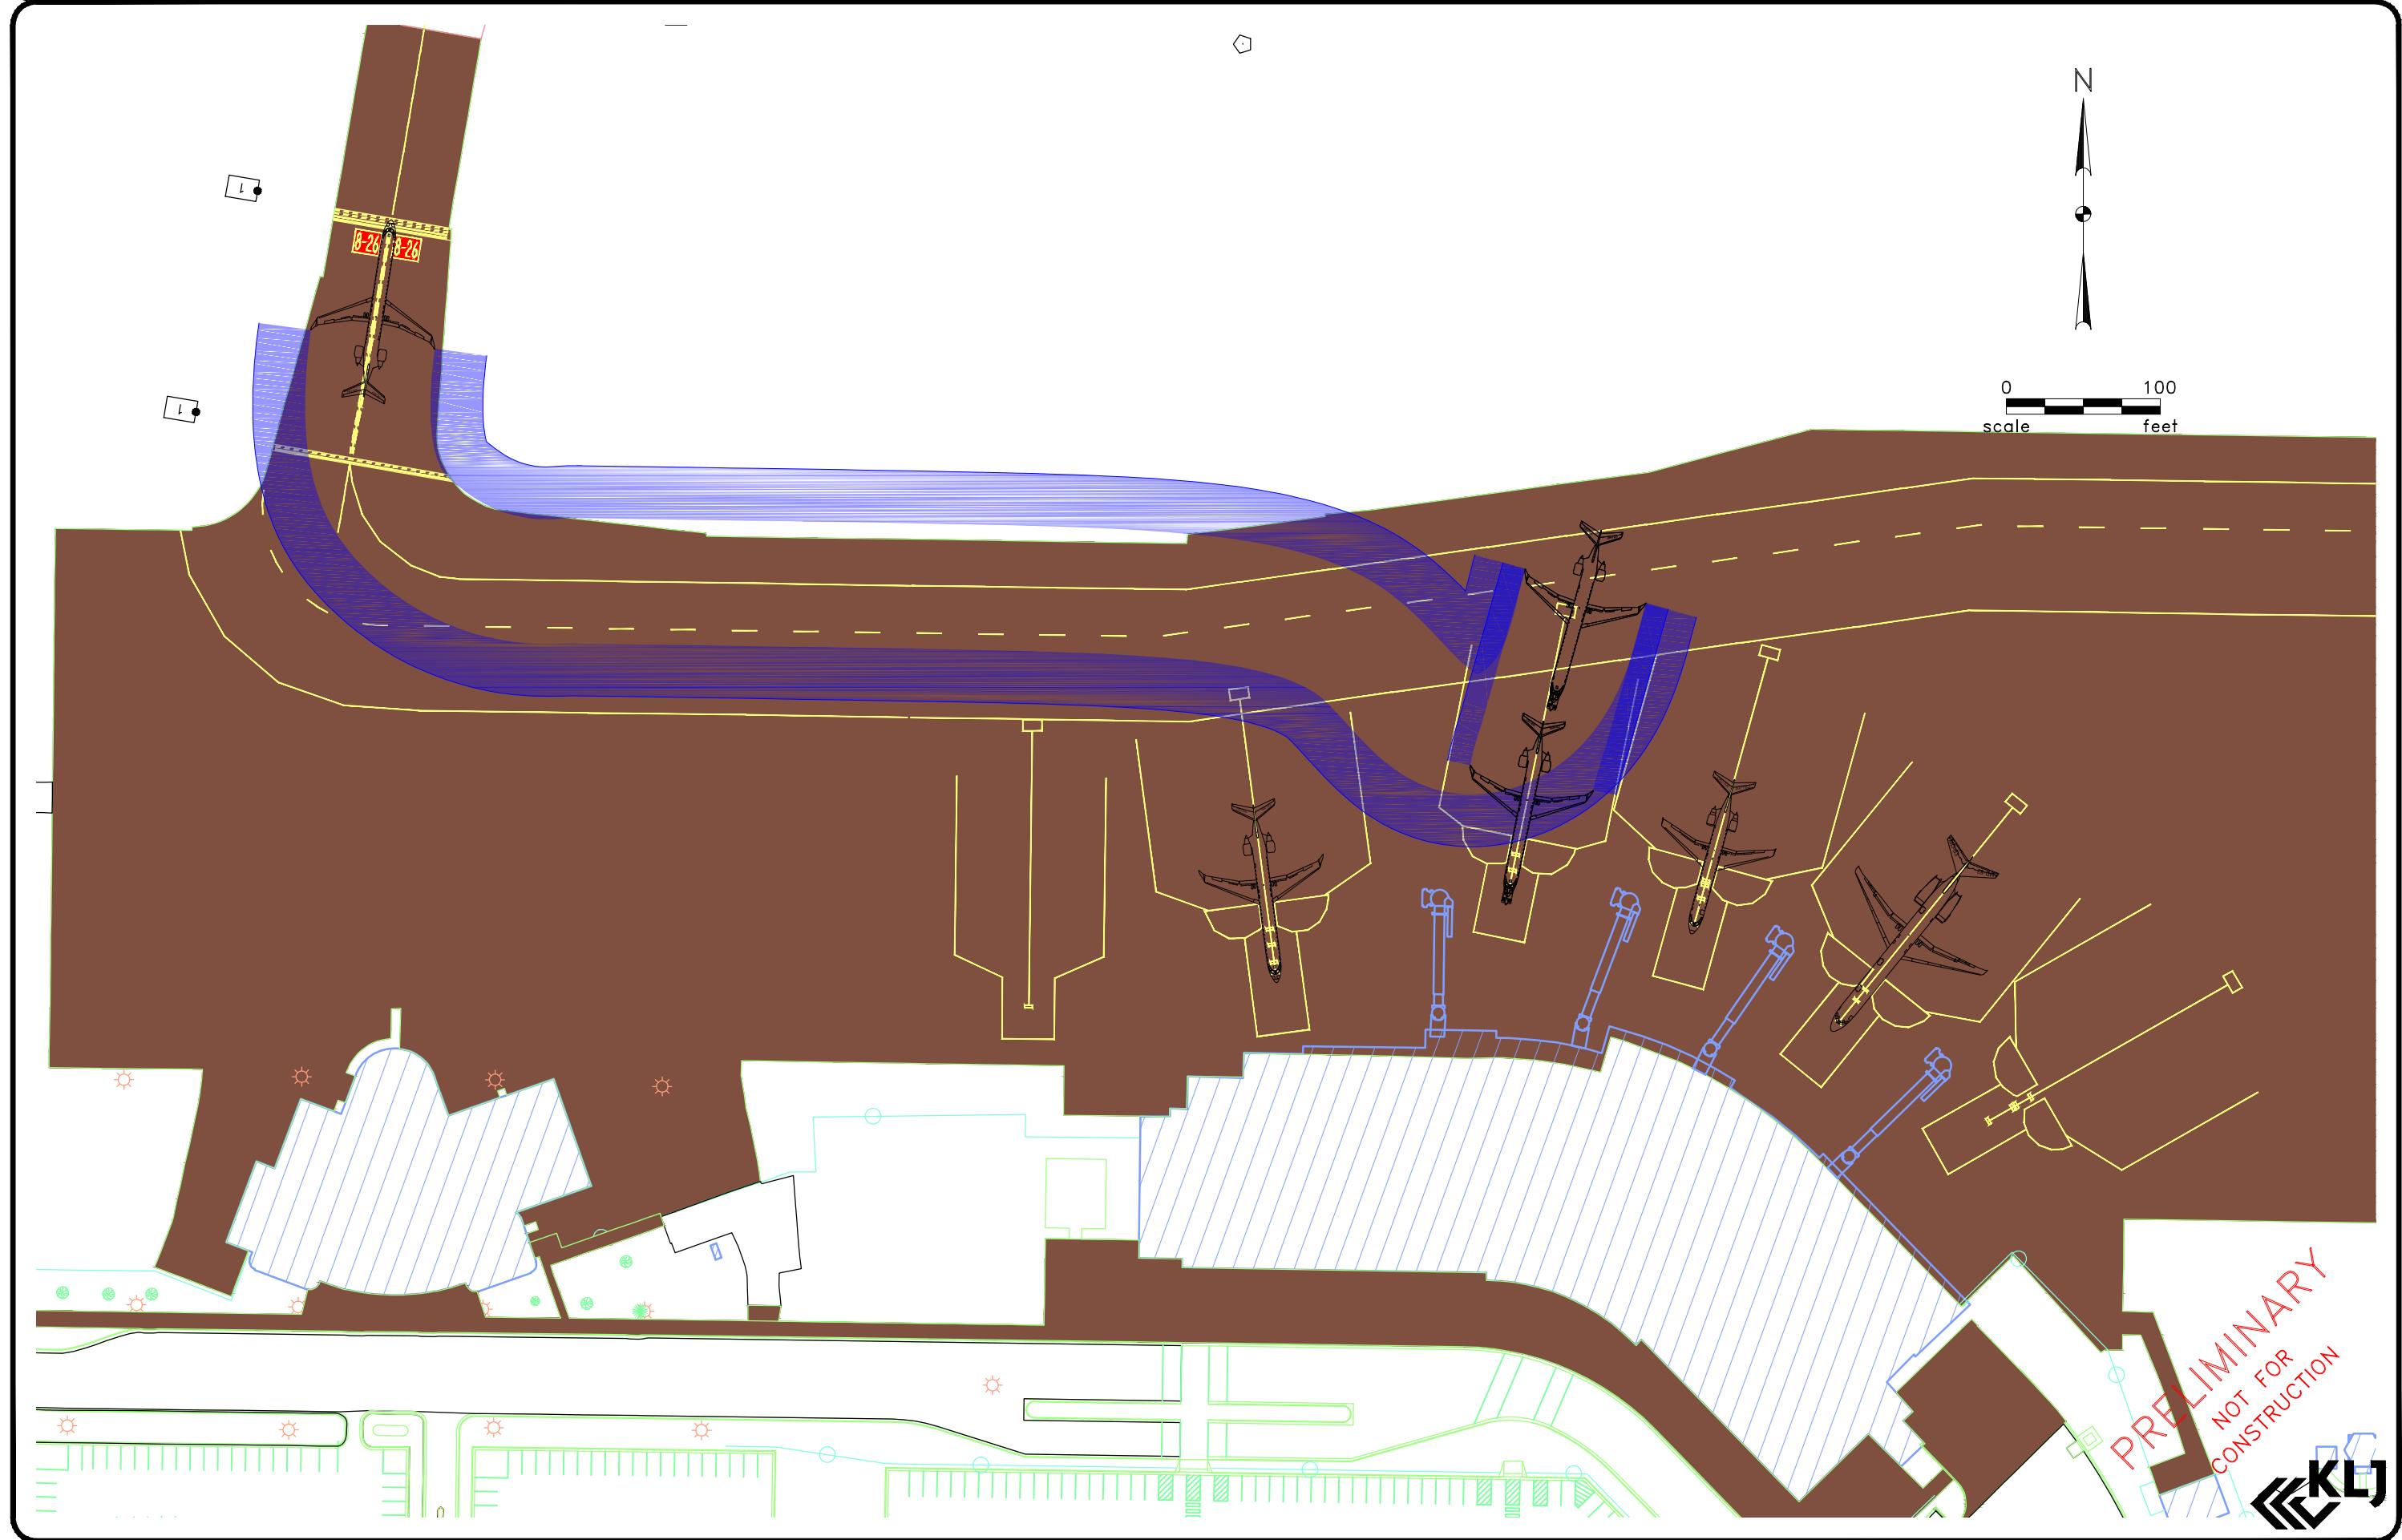
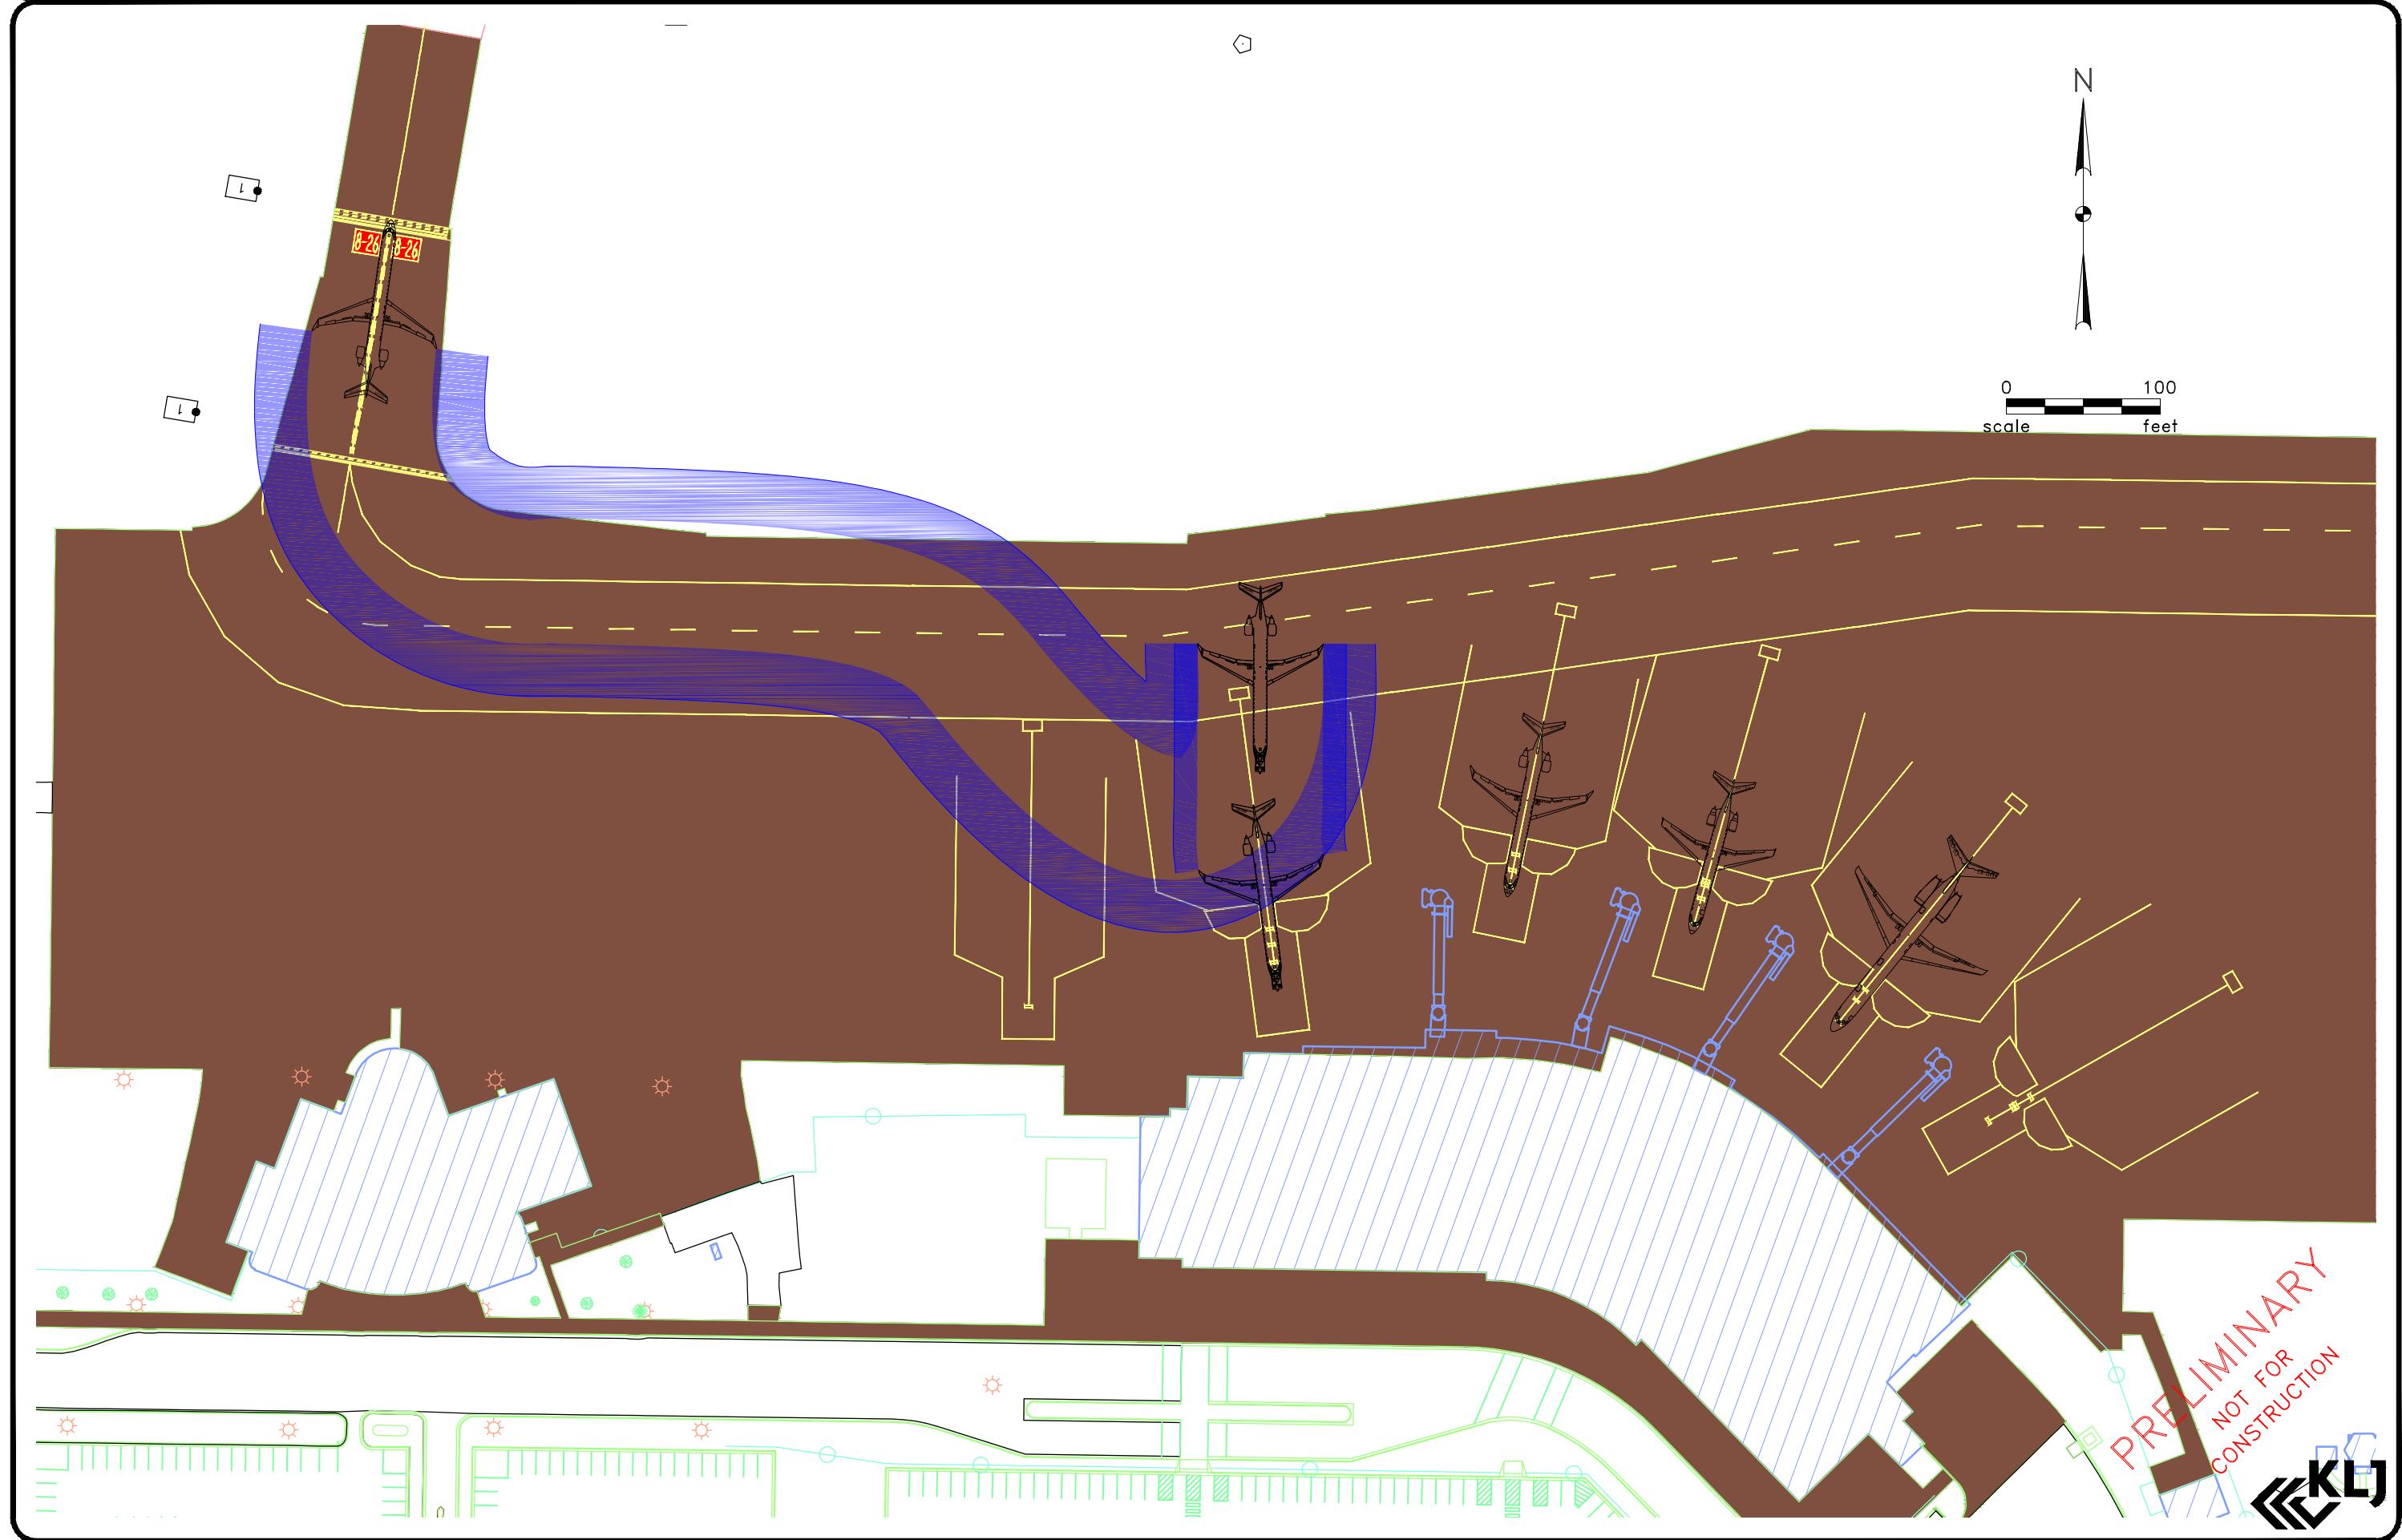
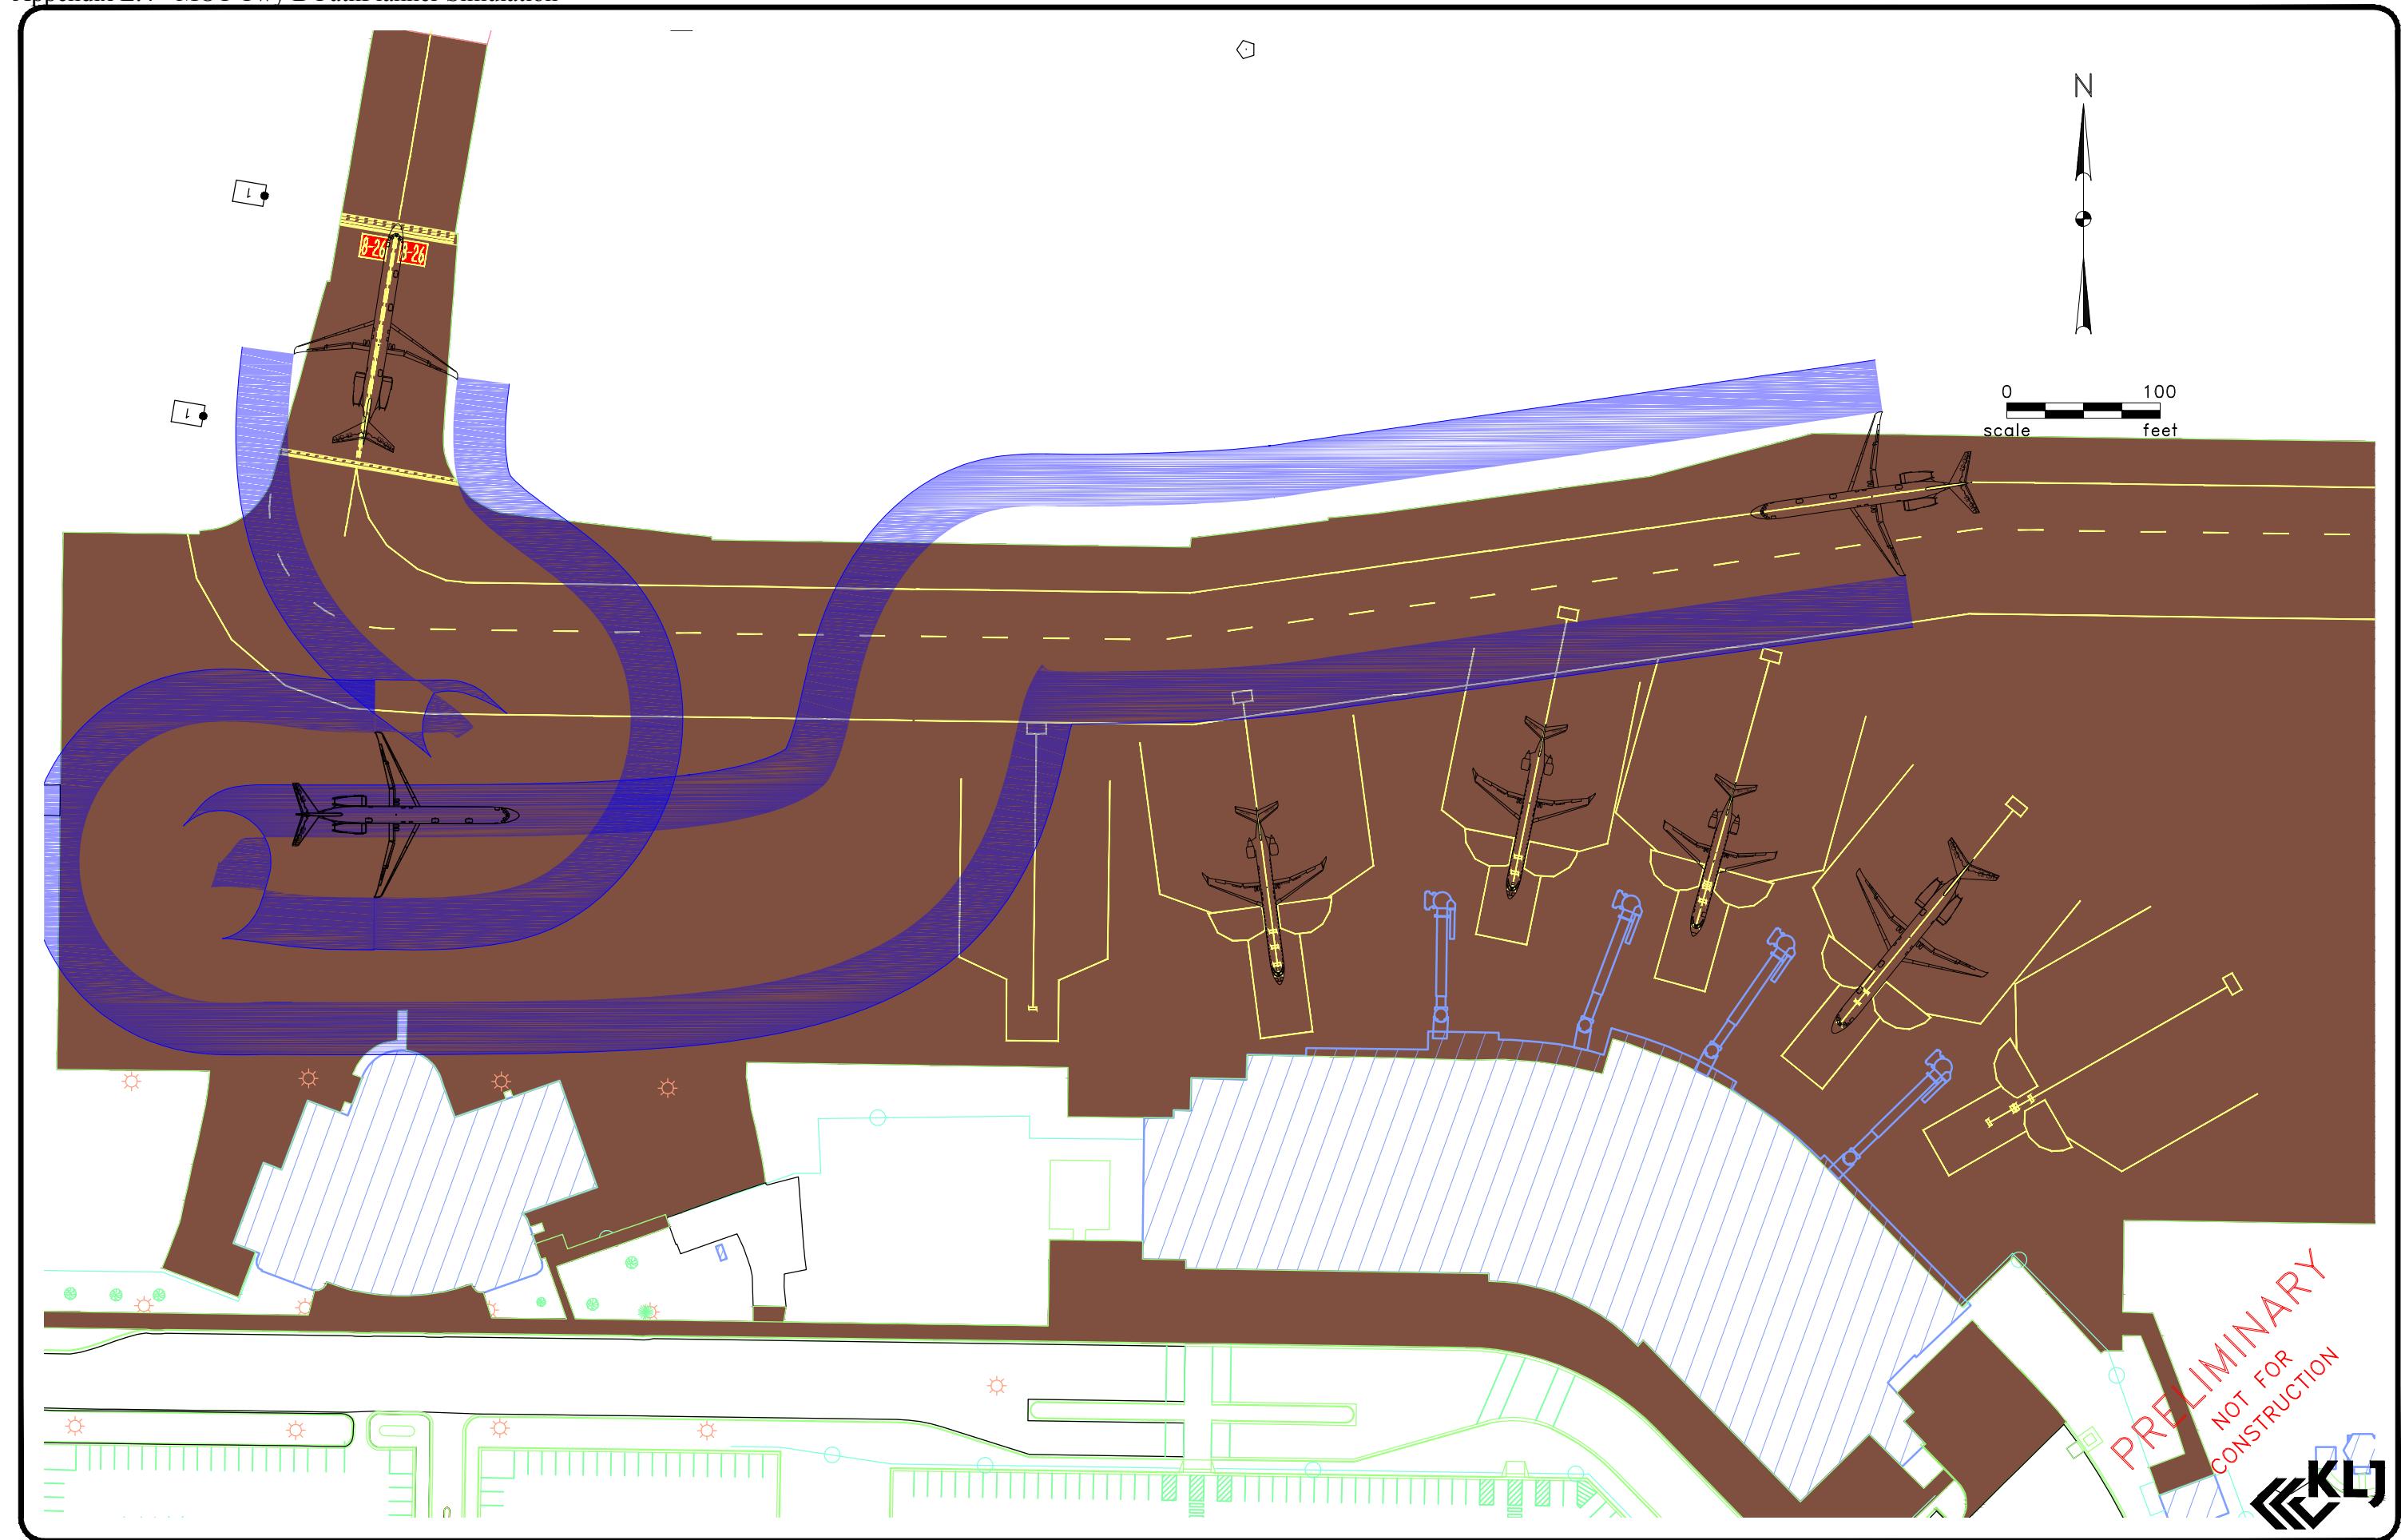
Appendix E.4 - MOT Twy B PathPlanner Simulation

Per the April 5th SRM Meeting regarding Minot International Airport, KLJ was asked to run a PathPlanner simulation showing aircraft movement from the airline terminal building to Taxiway B. These simulations used the largest aircraft regularly operating from each of the respective gates. The typical push back was used which is north for most gates (except Gate 2 which is southeast). A simulation was also completed showing an aircraft taxiing to deice on the old terminal apron (west of existing terminal) and then taxiing to Taxiway B.

As is evident from the simulations, due to the narrow depth of the apron and the required east-west movement of all aircraft, there were no circumstances where an aircraft was able to taxi onto Taxiway B without making a 90 degree turn. It is true that AC 150/5300-13A includes 401 (b)(5)(g) Indirect Access, but in the circumstance at Minot a turn is required. It is not possible for a pilot to be 'heads-down' in the cockpit while on the apron and inadvertently enter the taxiway headed toward the runway. We would ask that when a long term solution is determined for Taxiway B that this simulation be considered.
