APPENDIX J - SUPPORT FACILITIES

MINOT FIRE STATION NO. 3 - OPTION 1

RE: Fire Station #3 – Minot Airport
2510 N. Broadway-Minot, ND 58703

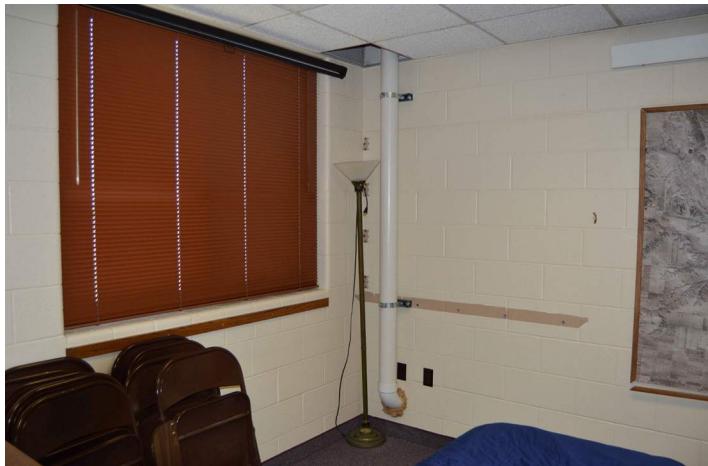
Living Area - Looking Northeast at Roof Drain Piping

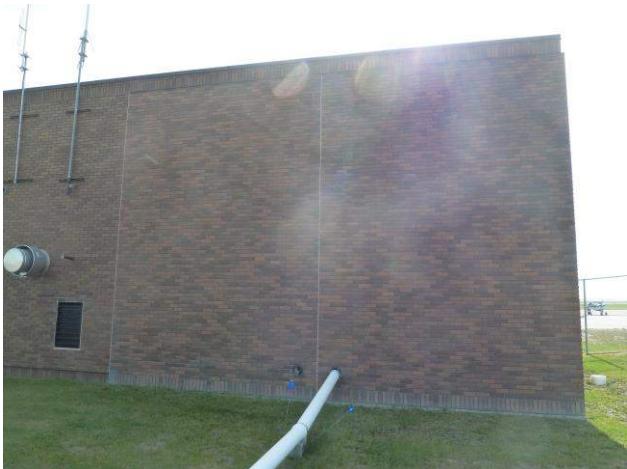
In walking around the outside perimeter of the building (See Photos #1 through #7), the brick veneer appeared to be in good condition with no signs of cracking that would indicate foundation movement. Drainage around the exterior of the site was poor. This was especially apparent at the west side of the building where there is an electrical courtyard with large rock bed landscaping. It is difficult to tell how well the grading provides drainage at this courtyard since the drainage depends on the actual grade of the soil below the rock. However, it is our opinion that the courtyard drainage is extremely poor and may be draining back toward the building as it appears to have nowhere to go and a low spot seemed to be present directly adjacent to the living quarters at the west wall. Another grading low spot was observed at the north side of the building directly adjacent to the foundation that may not allow proper drainage away from the building. Additionally, the general drainage at the south side of the building was extremely poor as well.

Photo #1 : West side of 2011 addition

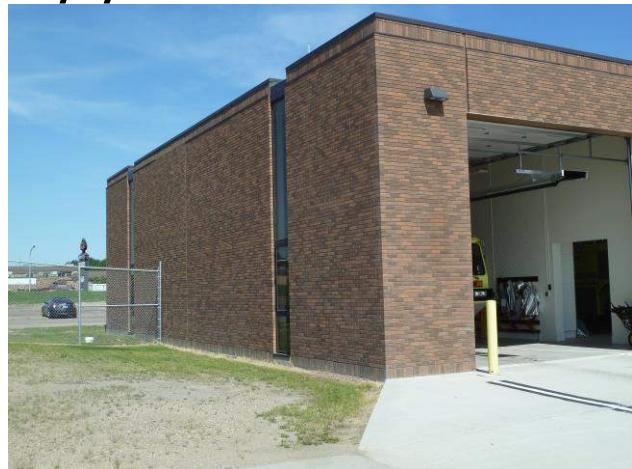
Photo #4: Southeast corner of 2011 addition.

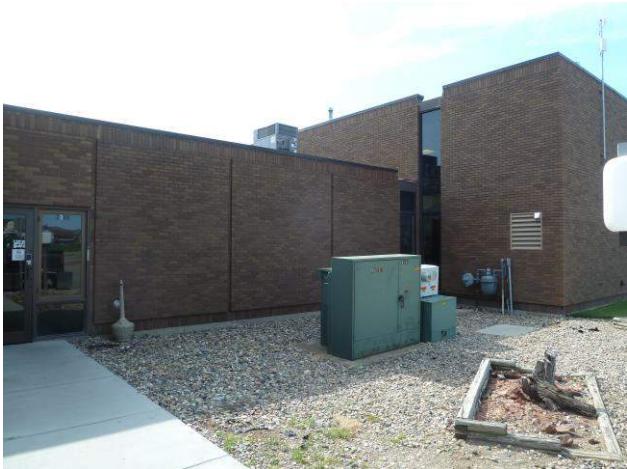
Photo #2:West side of Original 1973 Building showing Rock Courtyard.

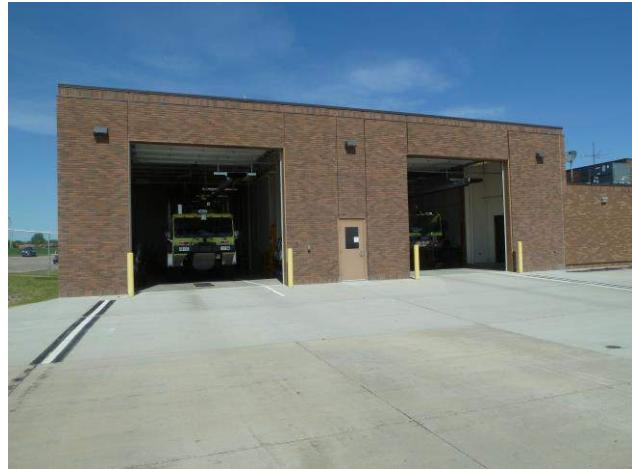
Photo #5: East side of 2011 addition.

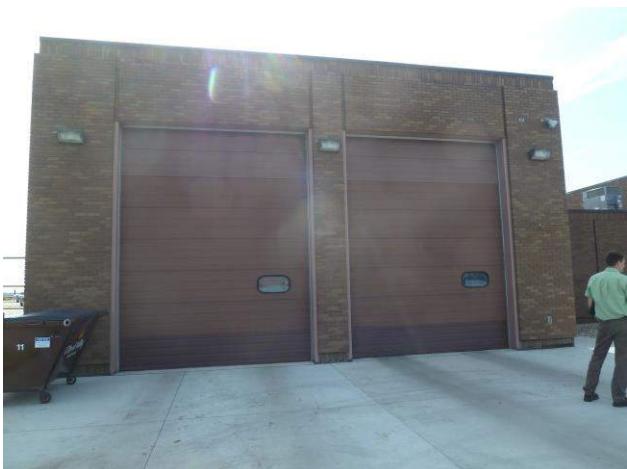
Photo #3: West side of 1978 apparatus bay.

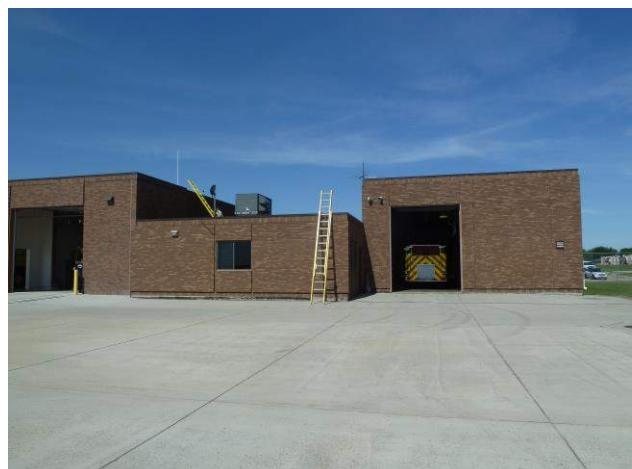
Photo #6 East side of building showing 2011 addition, original 1973 building & 1978 addition.

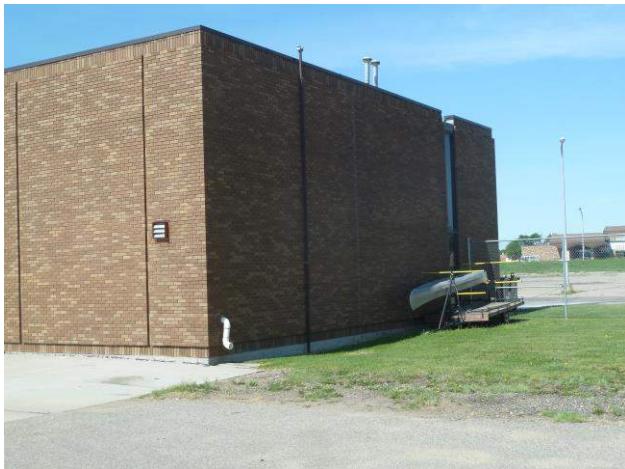
Photo #7: Northeast corner of 1978 addition.

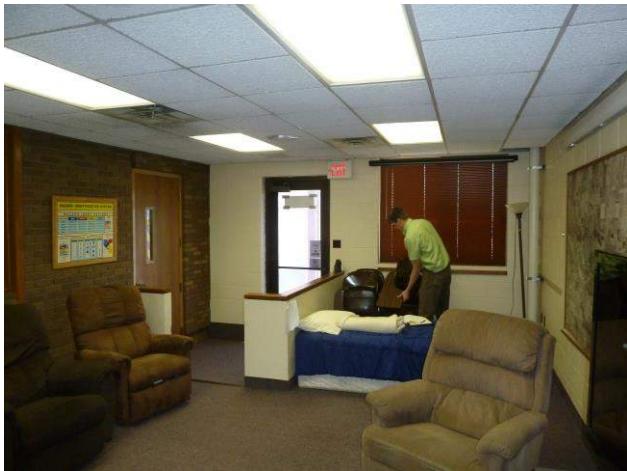
Photo #11: North wall of living quarters (East end).

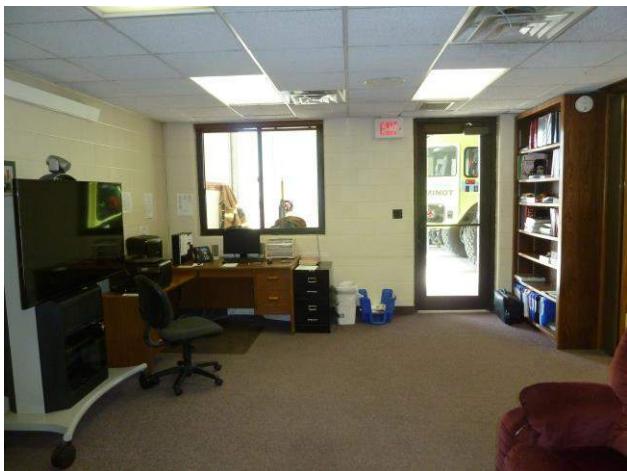
Photo #12: South wall of living quarters (East End)

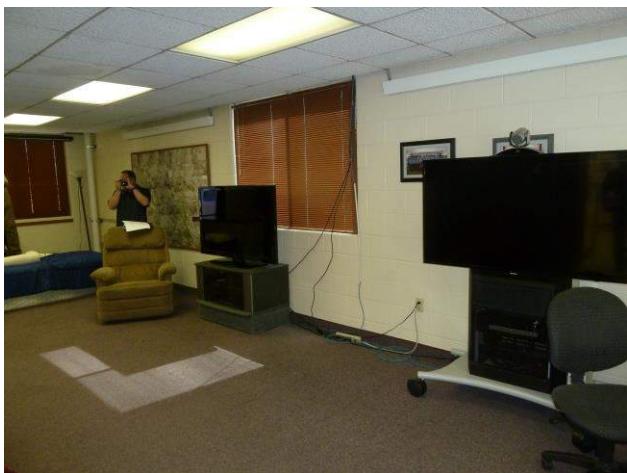
Photo #13: East wall of living quarters.

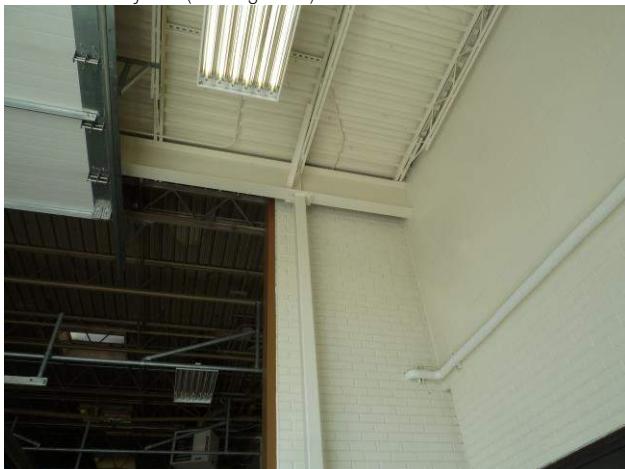
2011 Addition – A third apparatus bay was added south of the original apparatus bay in 2011 (See Photos #17, #19 through #21). The original apparatus bay was also extended approximately 16'-0" to the east at this time. The addition was constructed with concrete foundation walls and footings supporting 8" regular weight CMU bearing walls with brick veneer at exterior walls and a 12" CMU bearing wall between the third bay and the original bay extension. Steel column & beam lines were provided along the south and east walls of the original bay to support the new roof addition framing. These columns were supported on isolated pad footings underpinned along the existing construction. The roof framing of the addition consists of 10" steel bar joists spanning east-west at the original bay extension and 18" steel bar joists spanning north-south at the third bay addition, both supporting metal roof decking.

Photo #17: NE corner of original building apparatus bay, viewing 2011 steel column and beam line at west side of bay extension addition (Looking West)

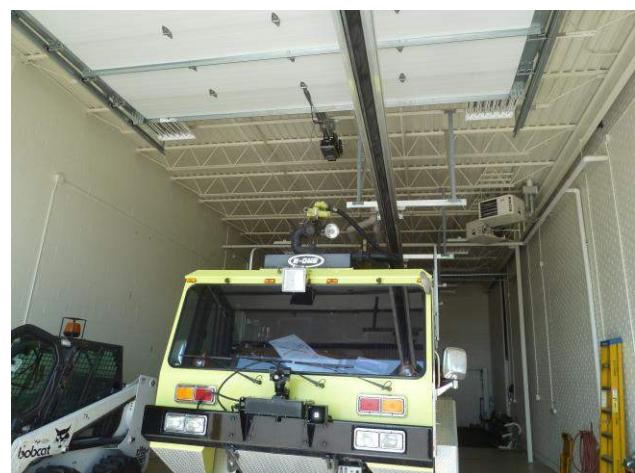
Photo #19: 2011 apparatus bay addition (looking west)
